School Assessment Report

District: Kentucky School of the Blind

Report: Apr 11, 2012

Condition Assessment: Oct 18, 2011

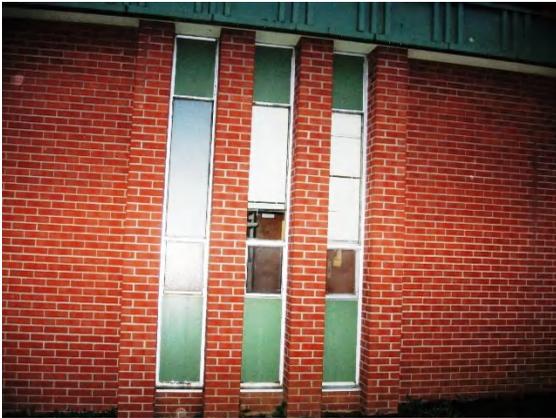
System: B2020 - Exterior Windows

Analysis: The system age is either beyond expected life or does not meet its intended performance under the Guidelines. The system may be in service and functioning but it is recommended to be replaced due to probable increased condition budget needs, the potential failure of its components, or in order to meet the performance Guidelines for this system. The system was installed in 1969. It has a 30-year service life which expired in 1999.

Recommendation: The system should be replaced.

Condition Budget: \$187,530

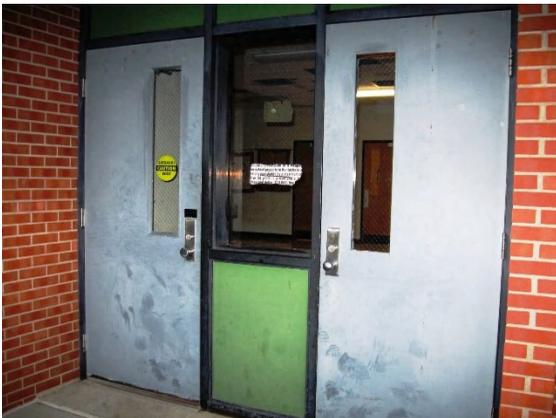
System: B2030 - Exterior Doors

Analysis: The system age is either beyond expected life or does not meet its intended performance under the Guidelines. The system may be in service and functioning but it is recommended to be replaced due to probable increased condition budget needs, the potential failure of its components, or in order to meet the performance Guidelines for this system. The system was installed in 1969. It has a 30-year service life which expired in 1999.

Recommendation: The system should be replaced.

Condition Budget: \$16,197

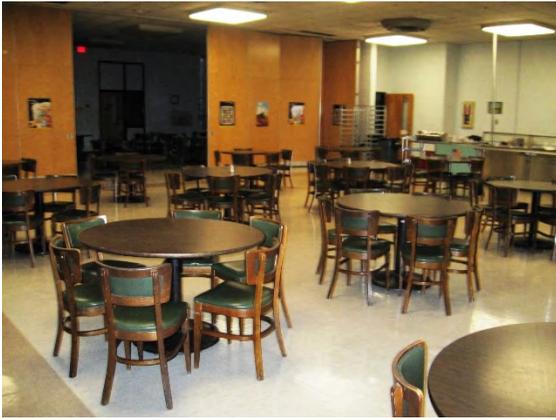
System: C1010 - Partitions

Analysis: The system age is either beyond expected life or does not meet its intended performance under the Guidelines. The system may be in service and functioning but it is recommended to be replaced due to probable increased condition budget needs, the potential failure of its components, or in order to meet the performance Guidelines for this system. The system was installed in 1969. It has a 40-year service life which expired in 2009.

Recommendation: The system should be replaced.

Condition Budget: \$114,872

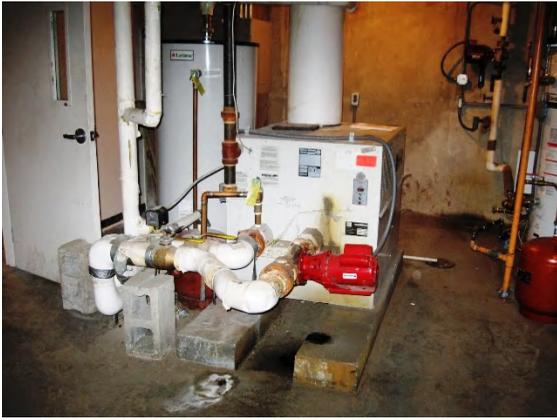
System: D2020 - Domestic Water Distribution

Analysis: The system age is either beyond expected life or does not meet its intended performance under the Guidelines. The system may be in service and functioning but it is recommended to be replaced due to probable increased condition budget needs, the potential failure of its components, or in order to meet the performance Guidelines for this system. The system was installed in 1969. It has a 30-year service life which expired in 1999.

Notes: Domestic hot water heater and pumps were replaced in 1998, however the piping is original to 1969 construction date.

Recommendation: The system should be replaced.

Condition Budget: \$119,800

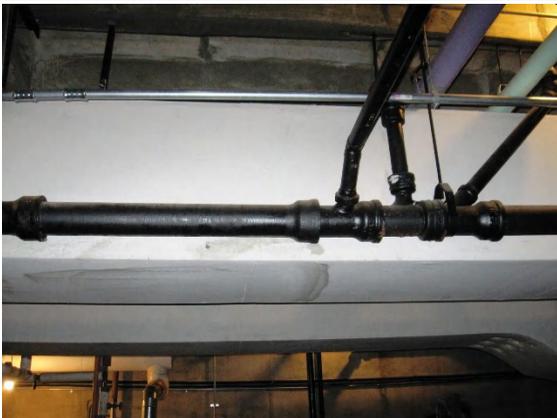
System: D2030 - Sanitary Waste

Analysis: The system age is either beyond expected life or does not meet its intended performance under the Guidelines. The system may be in service and functioning but it is recommended to be replaced due to probable increased condition budget needs, the potential failure of its components, or in order to meet the performance Guidelines for this system. The system was installed in 1969. It has a 30-year service life which expired in 1999.

Recommendation: The system should be replaced.

Condition Budget: \$74,190

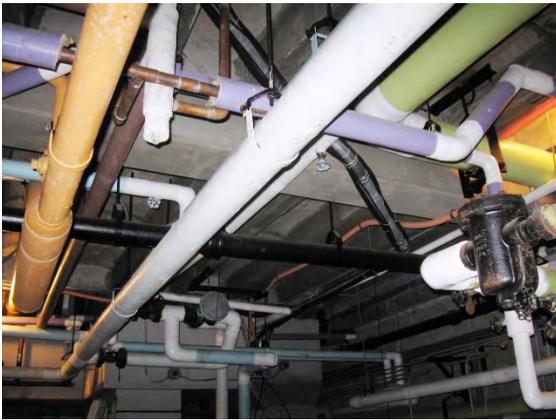
System: D3010 - Energy Supply-Steam Distribution

Analysis: The system age is either beyond expected life or does not meet its intended performance under the Guidelines. The system may be in service and functioning but it is recommended to be replaced due to probable increased condition budget needs, the potential failure of its components, or in order to meet the performance Guidelines for this system. The system was installed in 1969. It has a 30-year service life which expired in 1999.

Recommendation: The system should be replaced.

Condition Budget: \$108,006

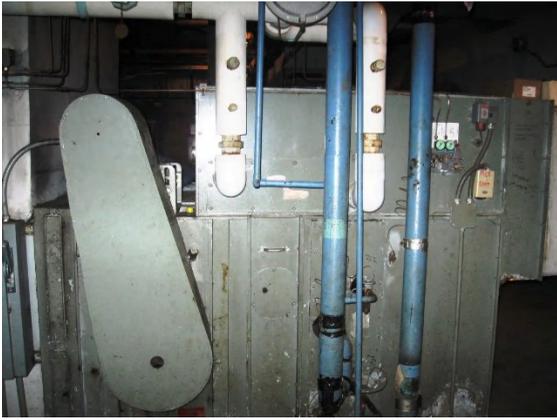
System: D3040 - Distribution Systems

Analysis: The system age is either beyond expected life or does not meet its intended performance under the Guidelines. The system may be in service and functioning but it is recommended to be replaced due to probable increased condition budget needs, the potential failure of its components, or in order to meet the performance Guidelines for this system. The system was installed in 1969. It has a 30-year service life which expired in 1999.

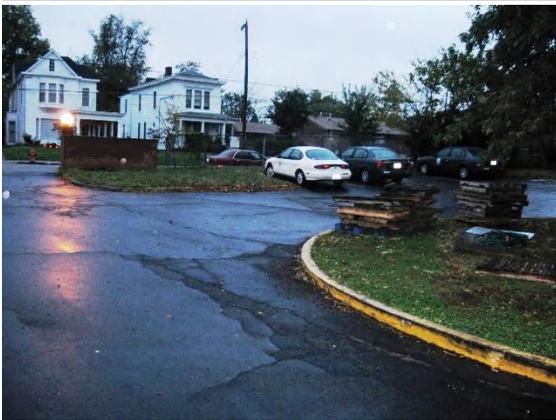
System: G2020 - Parking Lots

Analysis: The system age is either beyond expected life or does not meet its intended performance under the Guidelines. The system may be in service and functioning but it is recommended to be replaced due to probable increased condition budget needs, the potential failure of its components, or in order to meet the performance Guidelines for this system. The system was installed in 1969. It has a 30-year service life which expired in 1999.

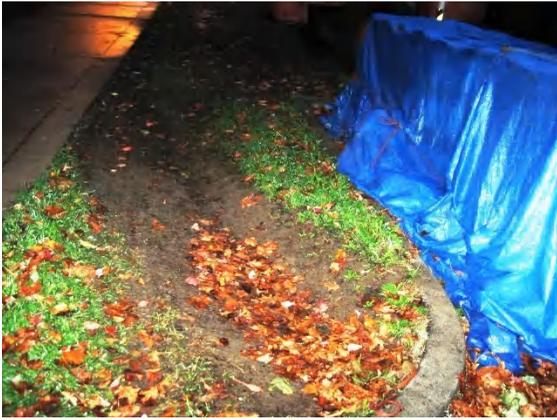
System: G2050 - Landscaping

Analysis: The system age is either beyond expected life or does not meet its intended performance under the Guidelines. The system may be in service and functioning but it is recommended to be replaced due to probable increased condition budget needs, the potential failure of its components, or in order to meet the performance Guidelines for this system. The system was installed in 1991. It has a 20-year service life. However, in the assessment, it was found to be currently deficient.

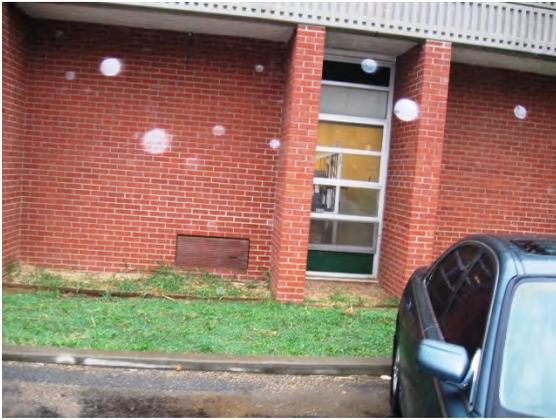
System: B2020 - Exterior Windows

Analysis: The system age is either beyond expected life or does not meet its intended performance under the Guidelines. The system may be in service and functioning but it is recommended to be replaced due to probable increased condition budget needs, the potential failure of its components, or in order to meet the performance Guidelines for this system. The system was installed in 1971. It has a 30-year service life which expired in 2001.

Condition Budget: \$211,580

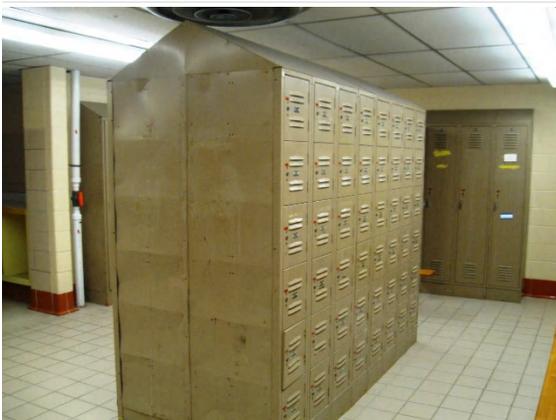
System: C1030 - Fittings

Location: Langan Gym
Distress: Beyond Expected Life
Category: Deferred Maintenance
Priority: 3 - Necessary- 2-5 Yrs
Correction: Renew System
Qty: 1-Ea.
Condition Budget: \$208,886

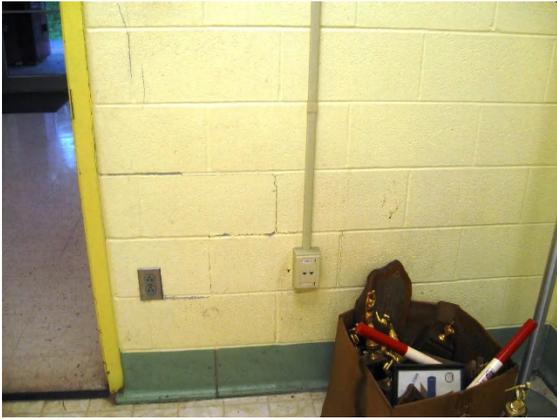
System: C3010 - Wall Finishes

Location: Langan Gym
Distress: Beyond Expected Life
Category: Deferred Maintenance
Priority: 3 - Necessary- 2-5 Yrs
Correction: Renew System
Qty: 1-Ea.
Condition Budget: \$212,154

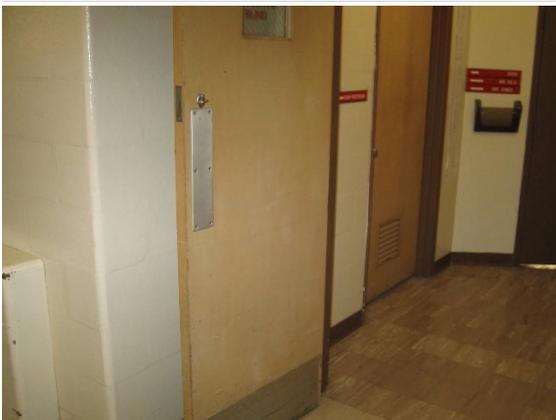
System: C1020 - Interior Doors

Location: Scoggan Classroom
Distress: Beyond Expected Life
Category: Deferred Maintenance
Priority: 3 - Necessary- 2-5 Yrs
Correction: Renew System
Qty: 1-Ea.
Condition Budget: \$142,491

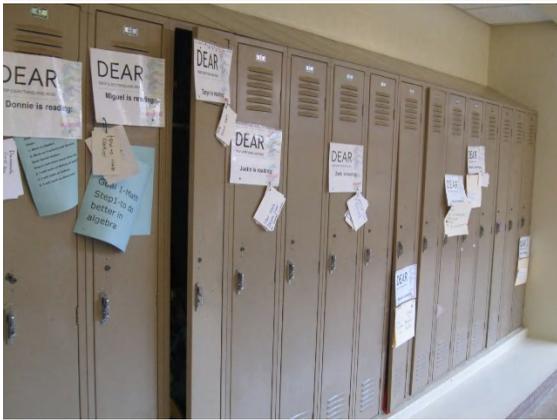
System: C1030 - Fittings

Condition Budget: \$147,231

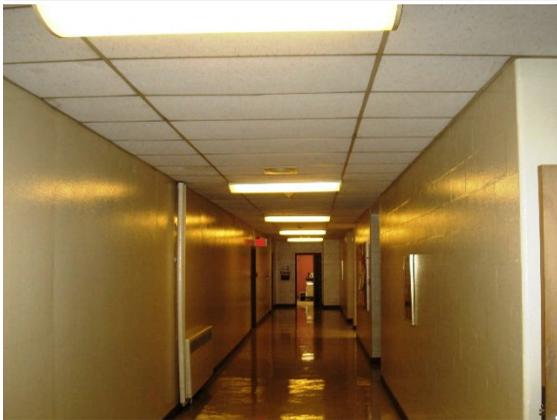
System: C3010 - Wall Finishes

Location: Scoggan Classroom
Distress: Beyond Expected Life
Category: Deferred Maintenance
Priority: 3 - Necessary- 2-5 Yrs
Correction: Renew System
Qty: 1-Ea.
Condition Budget: \$148,664

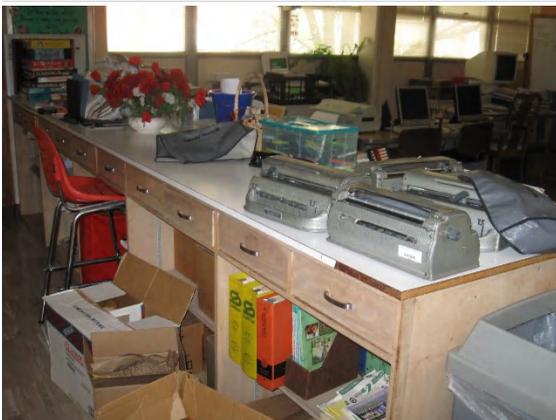
System: E2010 - Fixed Furnishings

Location: Scoggan Classroom
Distress: Beyond Expected Life
Category: Deferred Maintenance
Priority: 3 - Necessary- 2-5 Yrs
Correction: Renew System
Qty: 1-Ea.
Condition Budget: \$201,551
