School Assessment Report

District: Kentucky School of the Deaf

Report: Apr 11, 2012

Condition Assessment: Nov 18, 2011

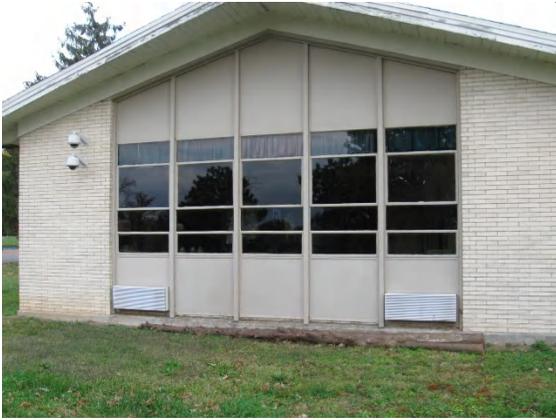
System: B2020 - Exterior Windows

Analysis: The system age is either beyond expected life or does not meet its intended performance under the Guidelines. The system may be in service and functioning but it is recommended to be replaced due to probable increased condition budget needs, the potential failure of its components, or in order to meet the performance Guidelines for this system. The system was installed in 1964. It has a 30-year service life which expired in 1994.

Recommendation: The system should be replaced.

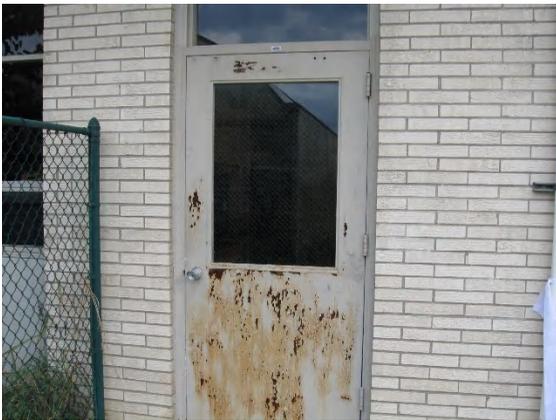
System: B2030 - Exterior Doors

Analysis: The system age is either beyond expected life or does not meet its intended performance under the Guidelines. The system may be in service and functioning but it is recommended to be replaced due to probable increased condition budget needs, the potential failure of its components, or in order to meet the performance Guidelines for this system. The system was installed in 1964. It has a 30-year service life which expired in 1994.

Recommendation: The system should be replaced.

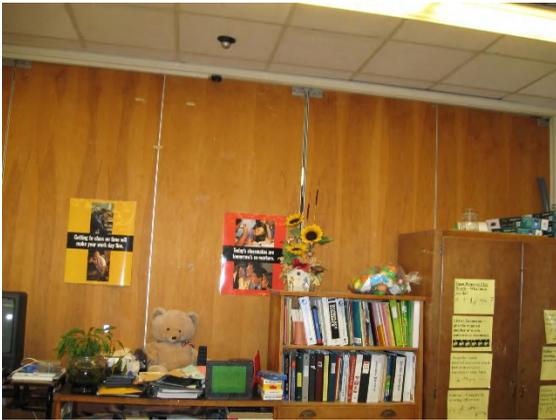
System: C1010 - Partitions

Analysis: The system age is either beyond expected life or does not meet its intended performance under the Guidelines. The system may be in service and functioning but it is recommended to be replaced due to probable increased condition budget needs, the potential failure of its components, or in order to meet the performance Guidelines for this system. The system was installed in 1964. It has a 40-year service life which expired in 2004.

Notes: CMU partitions are most likely not feasible to replace; however the facility overall is recommended to have major reconfiguration of interior spaces during any planned renovation or remodel.

Recommendation: The system should be replaced.

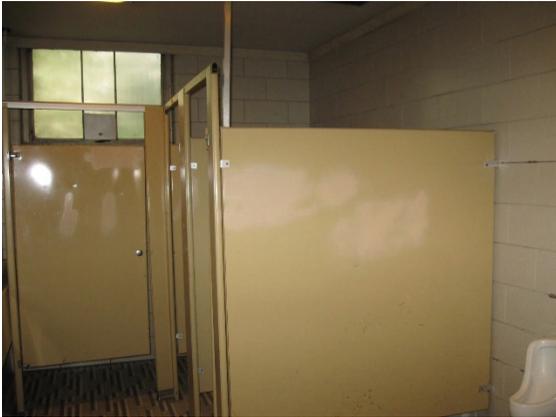
System: C1030 - Fittings

Analysis: The system age is either beyond expected life or does not meet its intended performance under the Guidelines. The system may be in service and functioning but it is recommended to be replaced due to probable increased condition budget needs, the potential failure of its components, or in order to meet the performance Guidelines for this system. The system was installed in 1964. It has a 20-year service life which expired in 1984.

Recommendation: The system should be replaced.

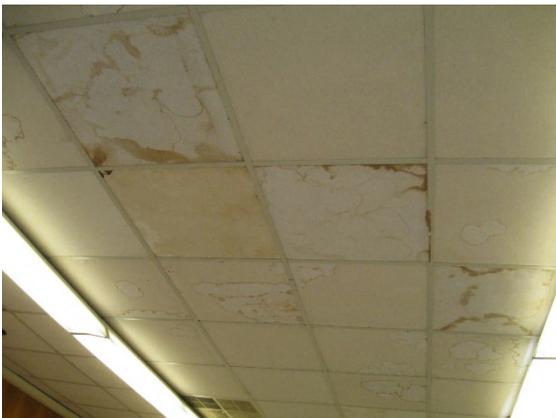
System: C3030 - Ceiling Finishes

Analysis: The system age is either beyond expected life or does not meet its intended performance under the Guidelines. The system may be in service and functioning but it is recommended to be replaced due to probable increased condition budget needs, the potential failure of its components, or in order to meet the performance Guidelines for this system. The system was installed in 1964. It has a 20-year service life which expired in 1984.

Recommendation: The system should be replaced.

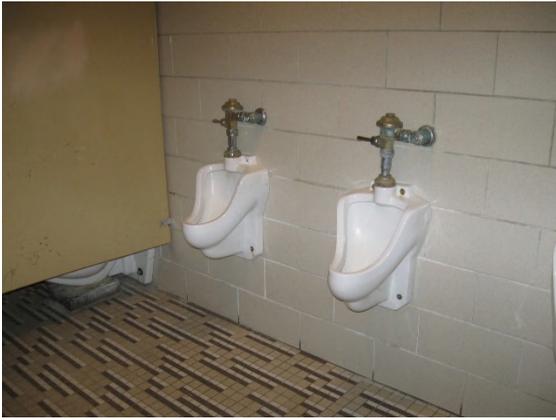
System: D2010 - Plumbing Fixtures

Analysis: The system age is either beyond expected life or does not meet its intended performance under the Guidelines. The system may be in service and functioning but it is recommended to be replaced due to probable increased condition budget needs, the potential failure of its components, or in order to meet the performance Guidelines for this system. The system was installed in 1964. It has a 30-year service life which expired in 1994.

Recommendation: The system should be replaced.

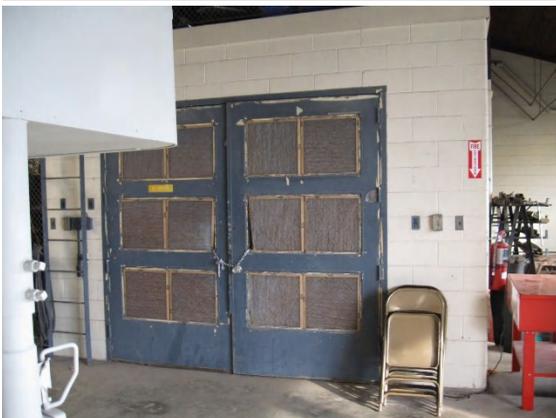
System: D3060 - Controls & Instrumentation

Analysis: The system is missing.

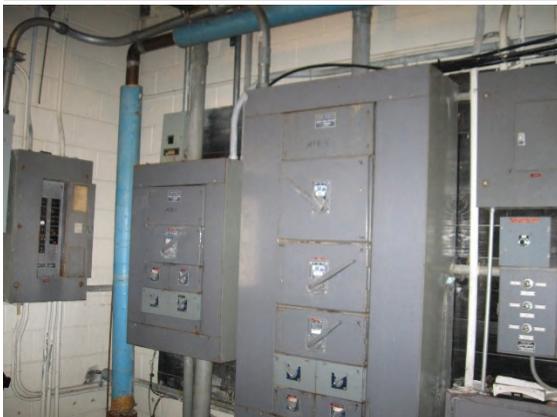
System: D5010 - Electrical Service/Distribution

Analysis: The system age is either beyond expected life or does not meet its intended performance under the Guidelines. The system may be in service and functioning but it is recommended to be replaced due to probable increased condition budget needs, the potential failure of its components, or in order to meet the performance Guidelines for this system. The system was installed in 1964. It has a 30-year service life which expired in 1994.

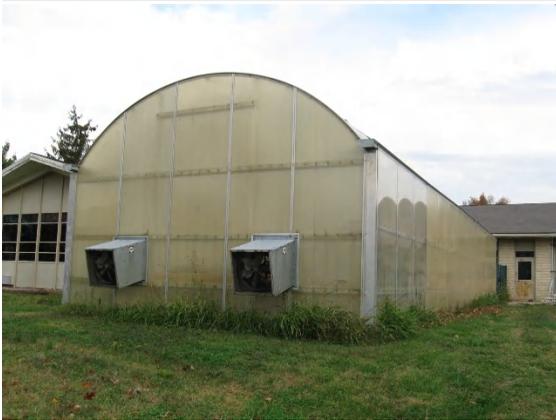
System: F1040 - Special Facilities-Green House

Analysis: The system age is either beyond expected life or does not meet its intended performance under the Guidelines. The system may be in service and functioning but it is recommended to be replaced due to probable increased condition budget needs, the potential failure of its components, or in order to meet the performance Guidelines for this system. The system was installed in 1985. It has a 20-year service life which expired in 2005.

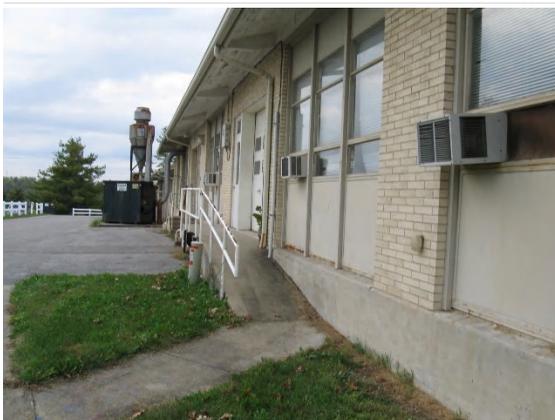
System: G2030 - Pedestrian Paving

Analysis: The system is in use and functioning but is recommended for renewal within the next 3 – 5 years. The system was installed in 1964. It has a 50-year service life. However, in the assessment, it was found to be currently deficient.

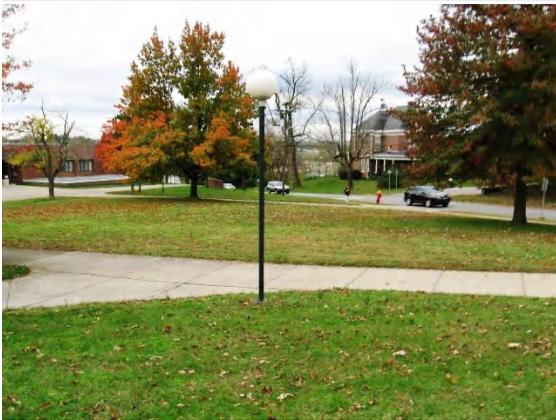
System: G4020 - Site Lighting

Analysis: The system age is either beyond expected life or does not meet its intended performance under the Guidelines. The system may be in service and functioning but it is recommended to be replaced due to probable increased condition budget needs, the potential failure of its components, or in order to meet the performance Guidelines for this system. The system was installed in 1964. It has a 30-year service life which expired in 1994.

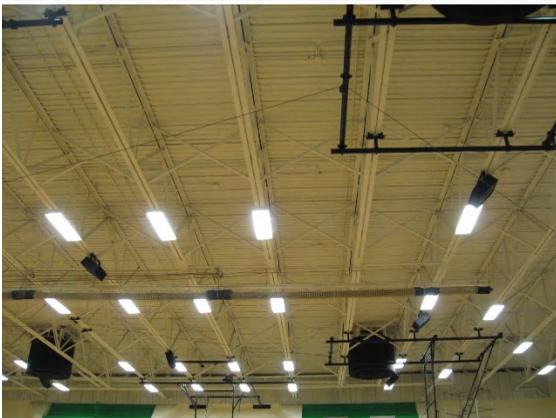
System: D3050 - Terminal & Package Units

Analysis: The system is missing.

Recommendation: The system should be replaced.
