School Assessment Report

District: Kentucky School of the Blind

Report: Apr 11, 2012

Condition Assessment: Oct 18, 2011

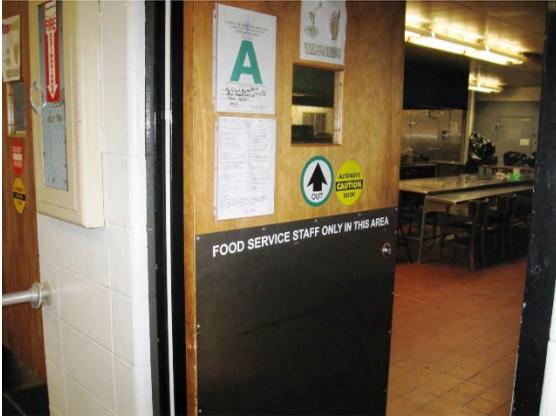
System: C1020 - Interior Doors

Analysis: The system age is either beyond expected life or does not meet its intended performance under the Guidelines. The system may be in service and functioning but it is recommended to be replaced due to probable increased condition budget needs, the potential failure of its components, or in order to meet the performance Guidelines for this system. The system was installed in 1969. It has a 40-year service life which expired in 2009.

Recommendation: The system should be replaced.

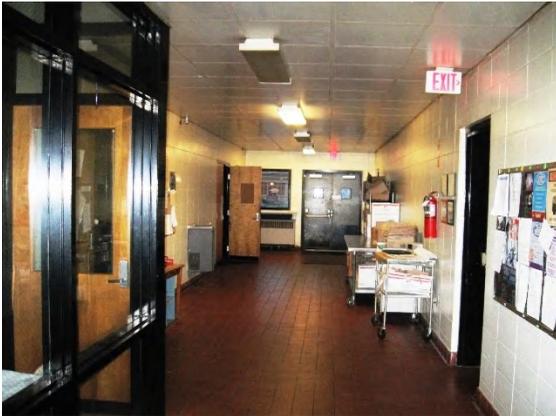
System: C3010 - Wall Finishes

Analysis: The system age is either beyond expected life or does not meet its intended performance under the Guidelines. The system may be in service and functioning but it is recommended to be replaced due to probable increased condition budget needs, the potential failure of its components, or in order to meet the performance Guidelines for this system. The system was installed in 1991. It has a 10-year service life which expired in 2001.

Recommendation: The system should be replaced.

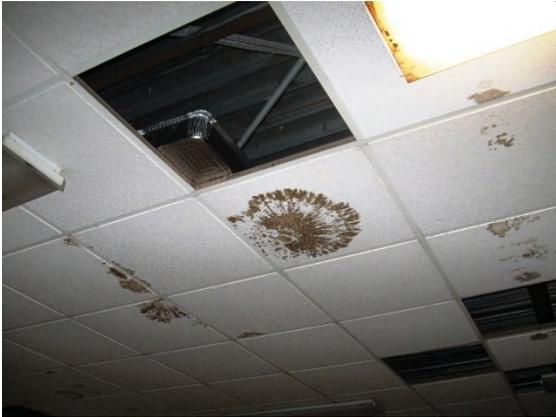
System: C3030 - Ceiling Finishes

Location: Hartford Food Service Cntr
Distress: Beyond Expected Life
Category: Deferred Maintenance
Priority: 3 - Necessary- 2-5 Yrs
Correction: Renew System
Qty: 1-Ea.
Condition Budget: \$223,016

Analysis: The system age is either beyond expected life or does not meet its intended performance under the Guidelines. The system may be in service and functioning but it is recommended to be replaced due to probable increased condition budget needs, the potential failure of its components, or in order to meet the performance Guidelines for this system. The system was installed in 1991. It has a 20-year service life. However, in the assessment, it was found to be currently deficient.

Recommendation: The system should be replaced.

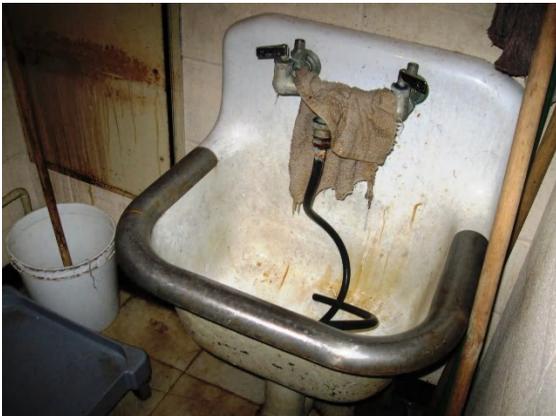
System: D2010 - Plumbing Fixtures

Location: Hartford Food Service Cntr
Distress: Beyond Expected Life
Category: Deferred Maintenance
Priority: 3 - Necessary- 2-5 Yrs
Correction: Renew System
Qty: 1-Ea.
Condition Budget: \$176,008

Analysis: The system age is either beyond expected life or does not meet its intended performance under the Guidelines. The system may be in service and functioning but it is recommended to be replaced due to probable increased condition budget needs, the potential failure of its components, or in order to meet the performance Guidelines for this system. The system was installed in 1969. It has a 30-year service life which expired in 1999.

Recommendation: The system should be replaced.

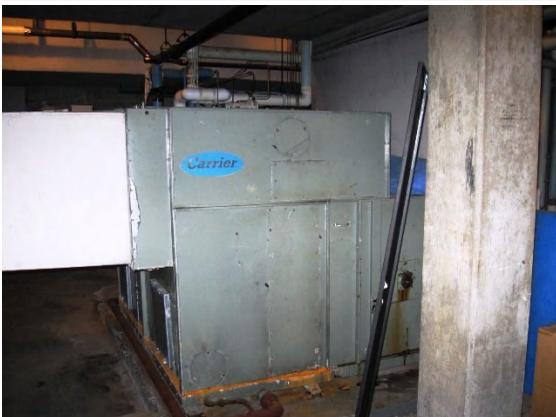
System: D3030 - Cooling Generating Systems

Analysis: The system age is either beyond expected life or does not meet its intended performance under the Guidelines. The system may be in service and functioning but it is recommended to be replaced due to probable increased condition budget needs, the potential failure of its components, or in order to meet the performance Guidelines for this system. The system was installed in 1969. It has a 30-year service life which expired in 1999.

Recommendation: The system should be replaced.

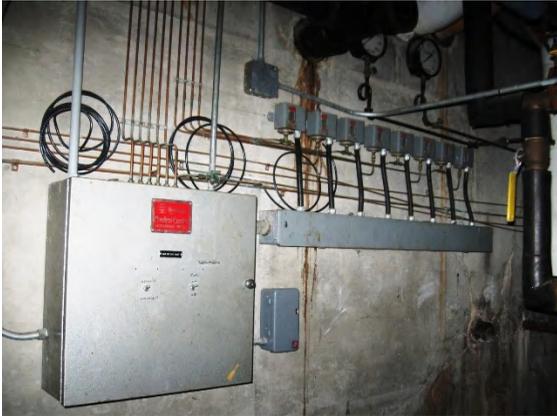
System: D3060 - Controls & Instrumentation

Analysis: The system age is either beyond expected life or does not meet its intended performance under the Guidelines. The system may be in service and functioning but it is recommended to be replaced due to probable increased condition budget needs, the potential failure of its components, or in order to meet the performance Guidelines for this system. The system was installed in 1969. It has a 20-year service life which expired in 1989.

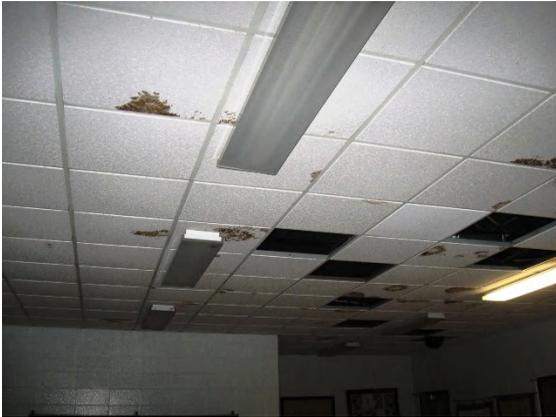
System: D5020 - Lighting and Branch Wiring

Location: Hartford Food Service Cntr
Distress: Beyond Expected Life
Category: Deferred Maintenance
Priority: 3 - Necessary- 2-5 Yrs
Correction: Renew System
Qty: 1-Ea.
Condition Budget: \$191,285

Analysis: The system age is either beyond expected life or does not meet its intended performance under the Guidelines. The system may be in service and functioning but it is recommended to be replaced due to probable increased condition budget needs, the potential failure of its components, or in order to meet the performance Guidelines for this system. The system was installed in 1969. It has a 30-year service life which expired in 1999.

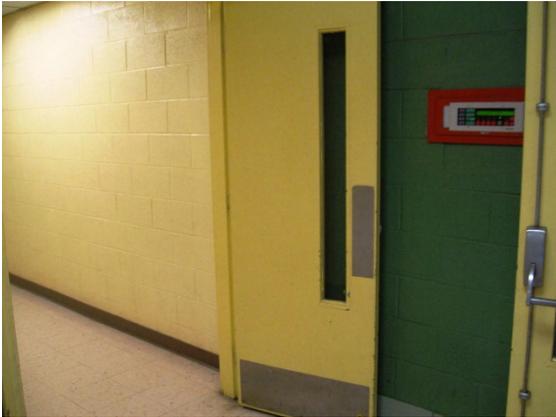
System: C1020 - Interior Doors

Location: Langan Gym
Distress: Beyond Expected Life
Category: Deferred Maintenance
Priority: 3 - Necessary- 2-5 Yrs
Correction: Renew System
Qty: 1-Ea.
Condition Budget: \$658,787

Analysis: The system age is either beyond expected life or does not meet its intended performance under the Guidelines. The system may be in service and functioning but it is recommended to be replaced due to probable increased condition budget needs, the potential failure of its components, or in order to meet the performance Guidelines for this system. The system was installed in 1971. It has a 40-year service life. However, in the assessment, it was found to be currently deficient.

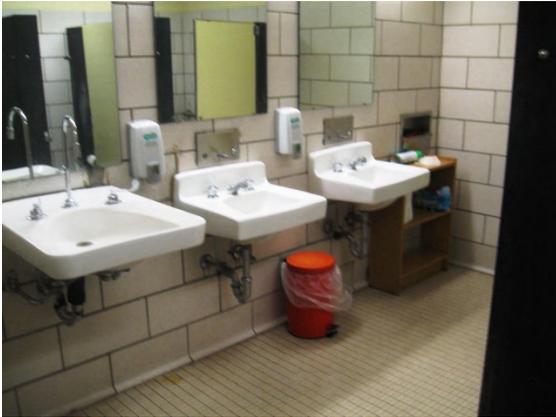
System: D2010 - Plumbing Fixtures

Location: Langan Gym
Distress: Beyond Expected Life
Category: Deferred Maintenance
Priority: 3 - Necessary- 2-5 Yrs
Correction: Renew System
Qty: 1-Ea.
Condition Budget: \$378,171

Analysis: The system age is either beyond expected life or does not meet its intended performance under the Guidelines. The system may be in service and functioning but it is recommended to be replaced due to probable increased condition budget needs, the potential failure of its components, or in order to meet the performance Guidelines for this system. The system was installed in 1971. It has a 30-year service life which expired in 2001.

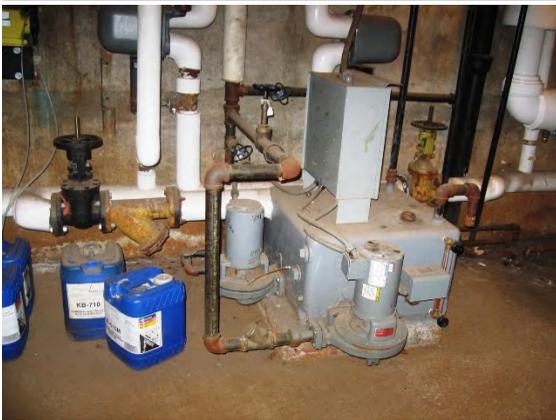
System: D3010 - Energy Supply

Analysis: The system age is either beyond expected life or does not meet its intended performance under the Guidelines. The system may be in service and functioning but it is recommended to be replaced due to probable increased condition budget needs, the potential failure of its components, or in order to meet the performance Guidelines for this system. The system was installed in 1971. It has a 30-year service life which expired in 2001.

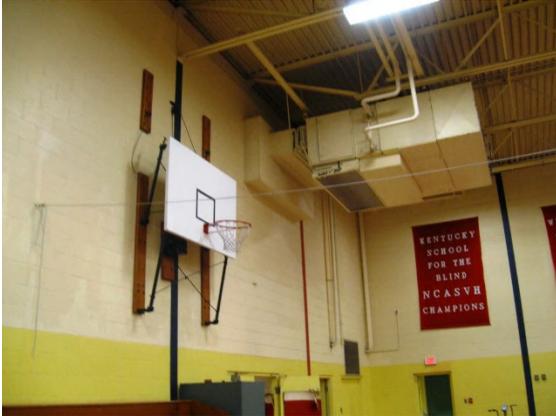
System: D3050 - Terminal & Package Units

Location: Langan Gym
Distress: Beyond Expected Life
Category: Deferred Maintenance
Priority: 3 - Necessary- 2-5 Yrs
Notes: Gym does not have cooling, heat only.
Correction: Renew System
Qty: 1-Ea.
Condition Budget: \$413,249

Analysis: The system is missing.
Recommendation: The system should be installed.

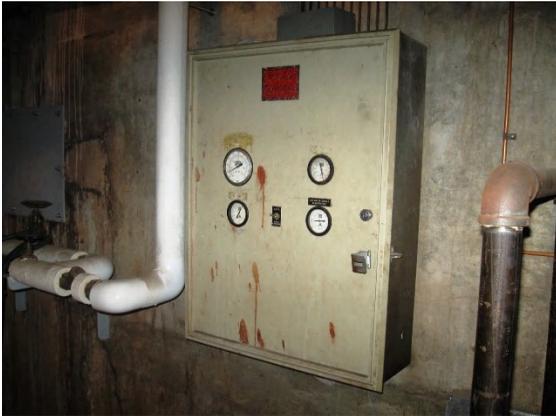
System: D3060 - Controls & Instrumentation

Location: Langan Gym
Distress: Missing
Category: Capital Renewal
Priority: 4 - Recommended-3-10 Yrs
Notes: Gym does not have cooling capabilities, heat only. Recommend adding package units with cooling and fresh air ventilation to better control IAQ in the gym. An Engineering Study of the HVAC requirements is recommended before any repairs or renovations are implemented.
Correction: Renew System
Qty: 1-Ea.
Condition Budget: \$1,254,880

Analysis: The system age is either beyond expected life or does not meet its intended performance under the Guidelines. The system may be in service and functioning but it is recommended to be replaced due to probable increased condition budget needs, the potential failure of its components, or in order to meet the performance Guidelines for this system. The system was installed in 1971. It has a 20-year service life which expired in 1991.
Recommendation: The system should be replaced.

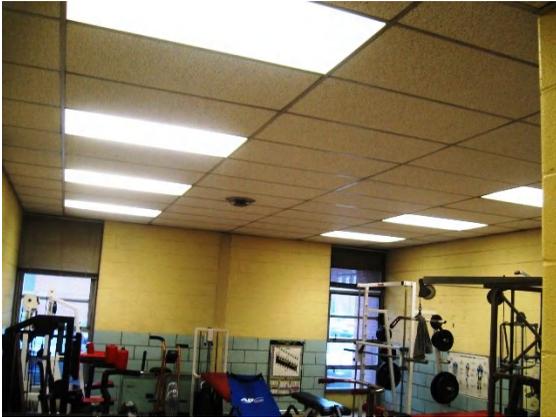
System: D5020 - Lighting and Branch Wiring

Location: Langan Gym
Distress: Beyond Expected Life
Category: Deferred Maintenance
Priority: 3 - Necessary- 2-5 Yrs
Correction: Renew System
Qty: 1-Ea.
Condition Budget: \$155,170

Analysis: The system age is either beyond expected life or does not meet its intended performance under the Guidelines. The system may be in service and functioning but it is recommended to be replaced due to probable increased condition budget needs, the potential failure of its components, or in order to meet the performance Guidelines for this system. The system was installed in 2004. It has a 30-year service life. However, in the assessment, it was found to be currently deficient.

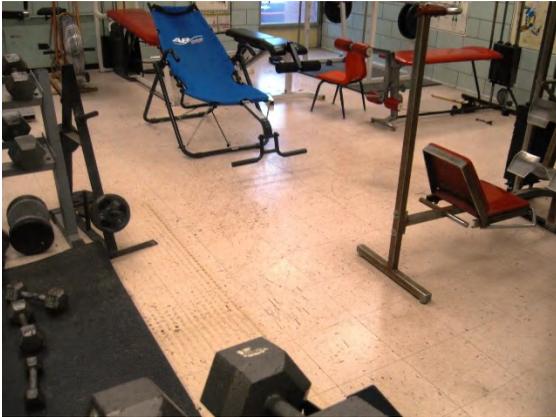
System: E1090 - Other Equipment-Athletic Equip

Location: Langan Gym
Distress: Beyond Expected Life
Category: Deferred Maintenance
Priority: 3 - Necessary- 2-5 Yrs
Correction: Renew System
Qty: 1-Ea.
Condition Budget: \$138,606

Analysis: The system age is either beyond expected life or does not meet its intended performance under the Guidelines. The system may be in service and functioning but it is recommended to be replaced due to probable increased condition budget needs, the potential failure of its components, or in order to meet the performance Guidelines for this system. The system was installed in 1971. It has a 20-year service life which expired in 1991.

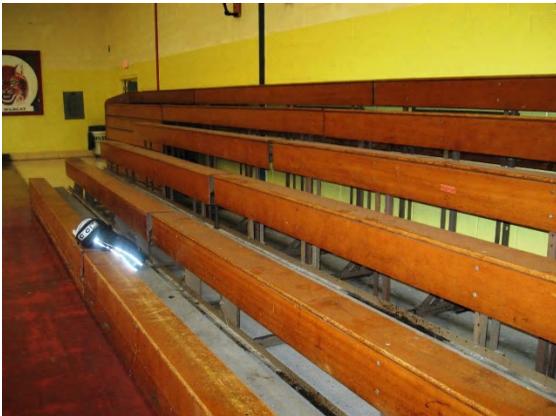
System: E2010 - Fixed Furnishings

Location: Langan Gym
Distress: Beyond Expected Life
Category: Deferred Maintenance
Priority: 3 - Necessary- 2-5 Yrs
Correction: Renew System
Qty: 1-Ea.
Condition Budget: \$88,663

Analysis: The system age is either beyond expected life or does not meet its intended performance under the Guidelines. The system may be in service and functioning but it is recommended to be replaced due to probable increased condition budget needs, the potential failure of its components, or in order to meet the performance Guidelines for this system. The system was installed in 1971. It has a 20-year service life which expired in 1991.

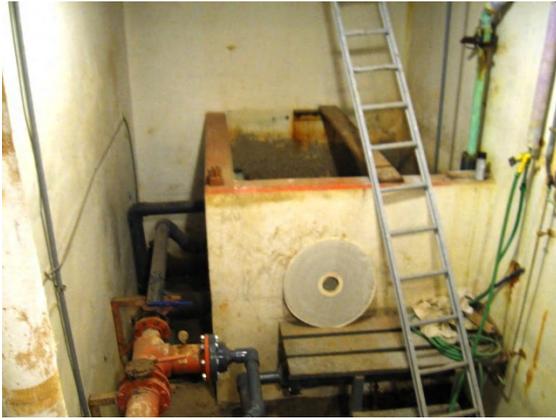
System: F1040 - Special Facilities-Swimming Pool

Analysis: The system is in use and functioning with an estimated remaining service life as indicated in the report section "Condition/Replacement Budget Detail". The system was installed in 2010. It has a 20-year service life. However, in the assessment, it was found to be currently deficient.

Recommendation: The system should be replaced.

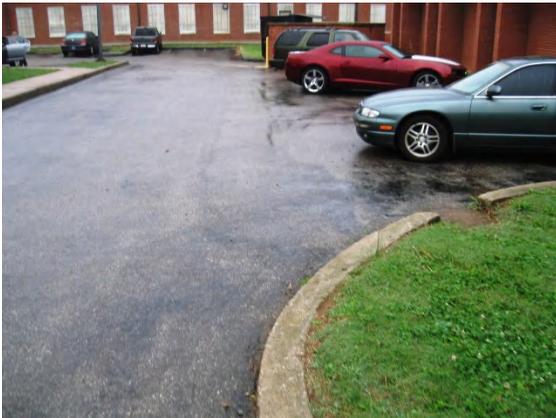
System: G2020 - Parking Lots

Analysis: The system age is either beyond expected life or does not meet its intended performance under the Guidelines. The system may be in service and functioning but it is recommended to be replaced due to probable increased condition budget needs, the potential failure of its components, or in order to meet the performance Guidelines for this system. The system was installed in 1971. It has a 30-year service life which expired in 2001.

Recommendation: The system should be replaced.

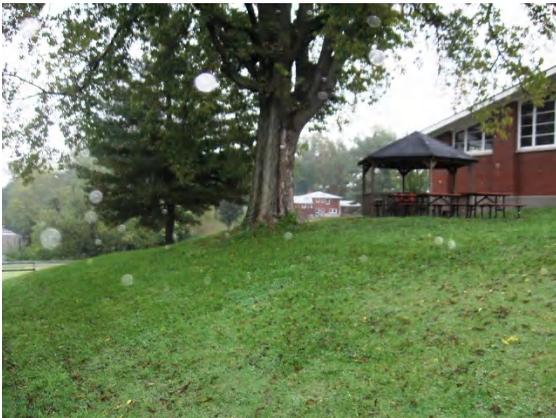
System: G2050 - Landscaping

Analysis: The system age is either beyond expected life or does not meet its intended performance under the Guidelines. The system may be in service and functioning but it is recommended to be replaced due to probable increased condition budget needs, the potential failure of its components, or in order to meet the performance Guidelines for this system. The system was installed in 1971. It has a 20-year service life which expired in 1991.

Recommendation: The system should be replaced.

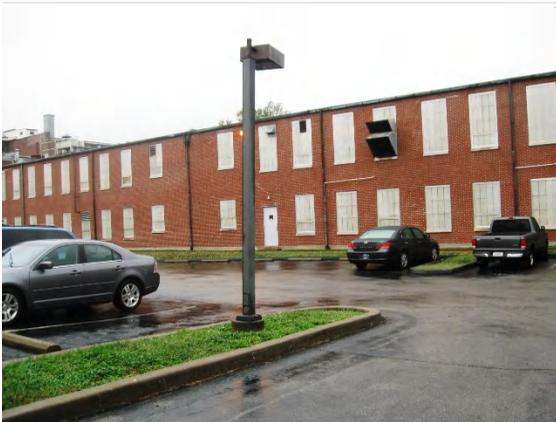
System: G4020 - Site Lighting

Analysis: The system age is either beyond expected life or does not meet its intended performance under the Guidelines. The system may be in service and functioning but it is recommended to be replaced due to probable increased condition budget needs, the potential failure of its components, or in order to meet the performance Guidelines for this system. The system was installed in 1971. It has a 30-year service life which expired in 2001.

Recommendation: The system should be replaced.

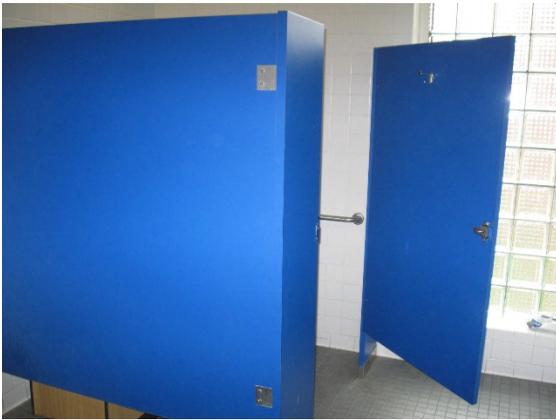
System: C1030 - Fittings

Analysis: The system age is either beyond expected life or does not meet its intended performance under the Guidelines. The system may be in service and functioning but it is recommended to be replaced due to probable increased condition budget needs, the potential failure of its components, or in order to meet the performance Guidelines for this system. The system was installed in 1985. It has a 20-year service life which expired in 2005.

Recommendation: The system should be replaced.

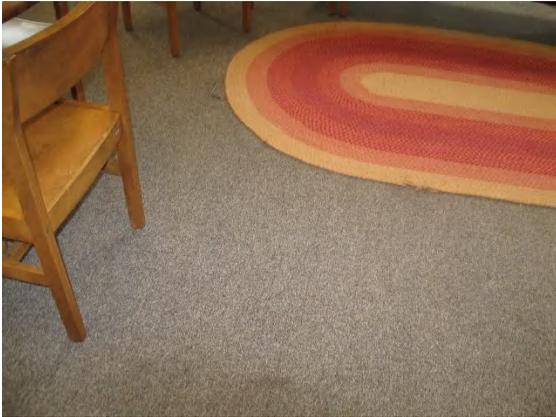
System: C3020 - Floor Finishes

Analysis: The system age is either beyond expected life or does not meet its intended performance under the Guidelines. The system may be in service and functioning but it is recommended to be replaced due to probable increased condition budget needs, the potential failure of its components, or in order to meet the performance Guidelines for this system. The system was installed in 1985. It has a 20-year service life which expired in 2005.

Recommendation: The system should be replaced.

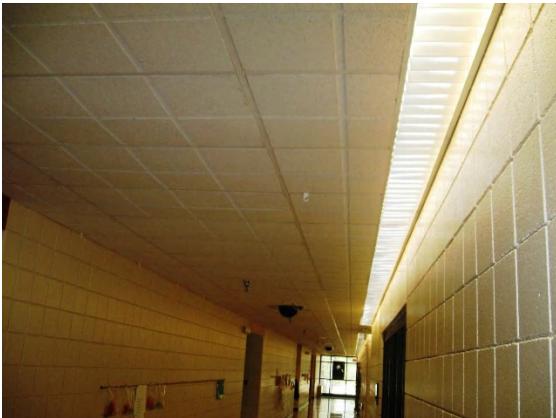
System: C3030 - Ceiling Finishes

Analysis: The system age is either beyond expected life or does not meet its intended performance under the Guidelines. The system may be in service and functioning but it is recommended to be replaced due to probable increased condition budget needs, the potential failure of its components, or in order to meet the performance Guidelines for this system. The system was installed in 1985. It has a 20-year service life which expired in 2005.

Recommendation: The system should be replaced.

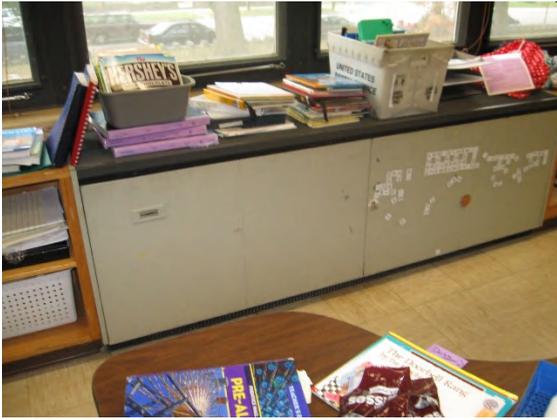
System: D3050 - Terminal & Package Units

Analysis: The system age is either beyond expected life or does not meet its intended performance under the Guidelines. The system may be in service and functioning but it is recommended to be replaced due to probable increased condition budget needs, the potential failure of its components, or in order to meet the performance Guidelines for this system. The system was installed in 1985. It has a 15-year service life which expired in 2000.

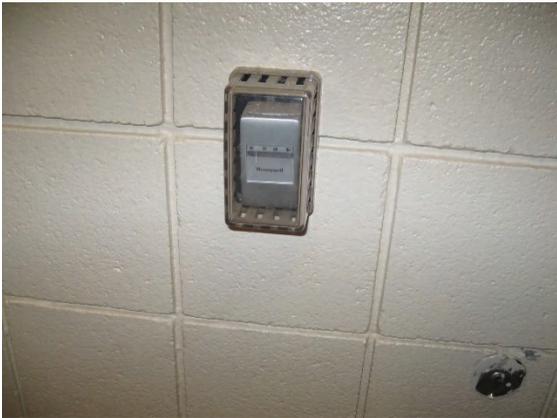
System: D3060 - Controls & Instrumentation

Analysis: The system age is either beyond expected life or does not meet its intended performance under the Guidelines. The system may be in service and functioning but it is recommended to be replaced due to probable increased condition budget needs, the potential failure of its components, or in order to meet the performance Guidelines for this system. The system was installed in 1985. It has a 20-year service life which expired in 2005.

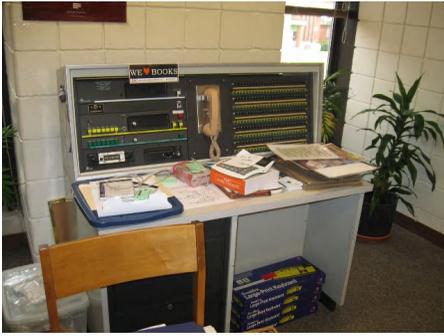
Location: McDaniel Classroom
Distress: Beyond Expected Life
Category: Deferred Maintenance
Priority: 3 - Necessary- 2-5 Yrs
Notes: Fire alarm, communication and security systems are recommended for upgrades and replacing as required.

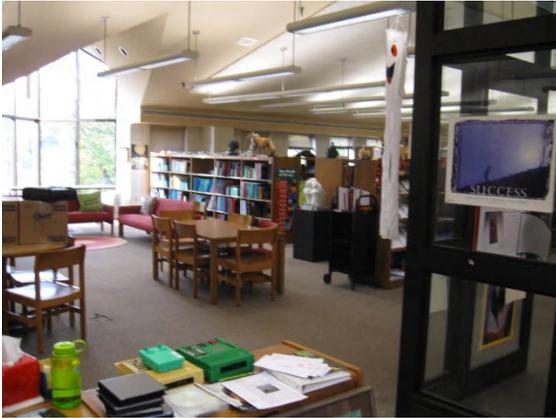
System: E1020 - Institutional Equipment

Analysis: The system age is either beyond expected life or does not meet its intended performance under the Guidelines. The system may be in service and functioning but it is recommended to be replaced due to probable increased condition budget needs, the potential failure of its components, or in order to meet the performance Guidelines for this system. The system was installed in 1985. It has a 20-year service life which expired in 2005.

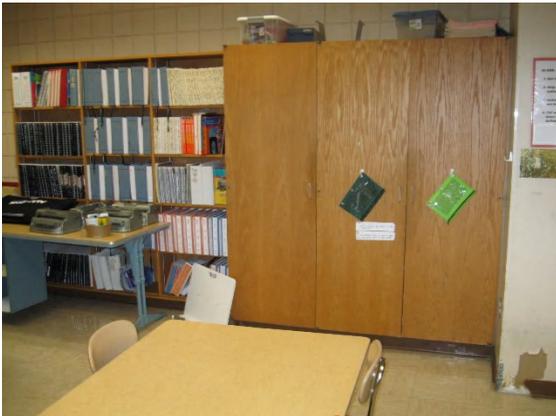
System: E2010 - Fixed Furnishings

Analysis: The system age is either beyond expected life or does not meet its intended performance under the Guidelines. The system may be in service and functioning but it is recommended to be replaced due to probable increased condition budget needs, the potential failure of its components, or in order to meet the performance Guidelines for this system. The system was installed in 1985. It has a 20-year service life which expired in 2005.

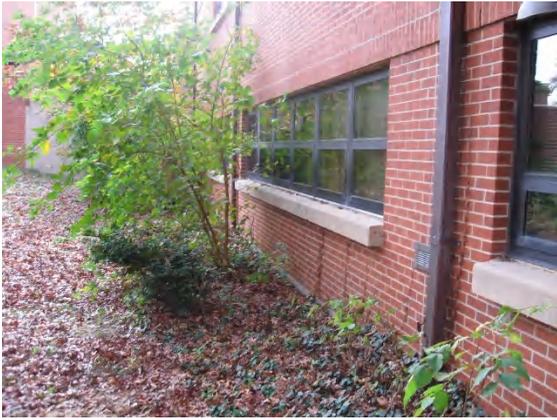
System: G2050 - Landscaping

Analysis: The system age is either beyond expected life or does not meet its intended performance under the Guidelines. The system may be in service and functioning but it is recommended to be replaced due to probable increased condition budget needs, the potential failure of its components, or in order to meet the performance Guidelines for this system. The system was installed in 1985. It has a 20-year service life which expired in 2005.

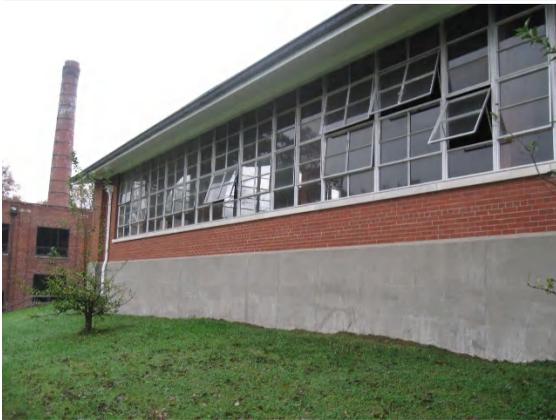
System: B2020 - Exterior Windows

Analysis: The system age is either beyond expected life or does not meet its intended performance under the Guidelines. The system may be in service and functioning but it is recommended to be replaced due to probable increased condition budget needs, the potential failure of its components, or in order to meet the performance Guidelines for this system. The system was installed in 1977. It has a 30-year service life which expired in 2007.

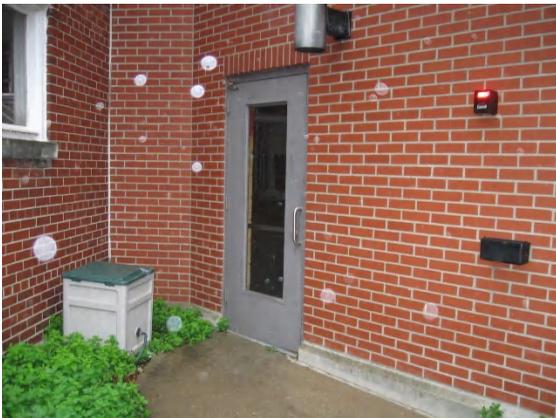
System: B2030 - Exterior Doors

Analysis: The system age is either beyond expected life or does not meet its intended performance under the Guidelines. The system may be in service and functioning but it is recommended to be replaced due to probable increased condition budget needs, the potential failure of its components, or in order to meet the performance Guidelines for this system. The system was installed in 1977. It has a 30-year service life which expired in 2007.

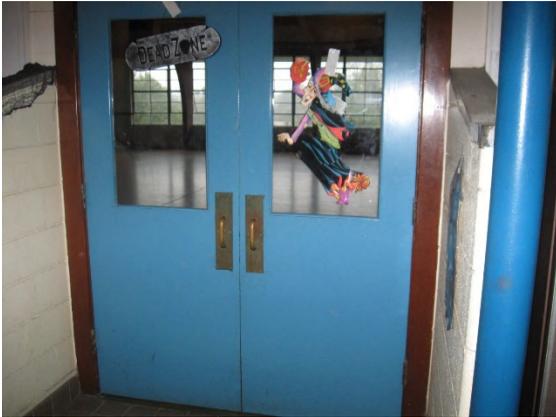
System: C1020 - Interior Doors

Analysis: The system age is either beyond expected life or does not meet its intended performance under the Guidelines. The system may be in service and functioning but it is recommended to be replaced due to probable increased condition budget needs, the potential failure of its components, or in order to meet the performance Guidelines for this system. The system was installed in 1955. It has a 40-year service life which expired in 1995.

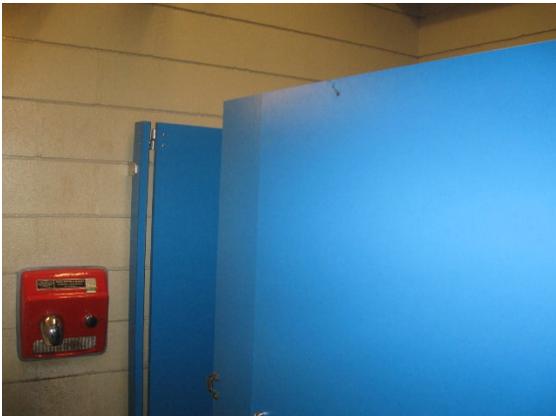
System: C1030 - Fittings

Analysis: The system age is either beyond expected life or does not meet its intended performance under the Guidelines. The system may be in service and functioning but it is recommended to be replaced due to probable increased condition budget needs, the potential failure of its components, or in order to meet the performance Guidelines for this system. The system was installed in 1977. It has a 20-year service life which expired in 1997.

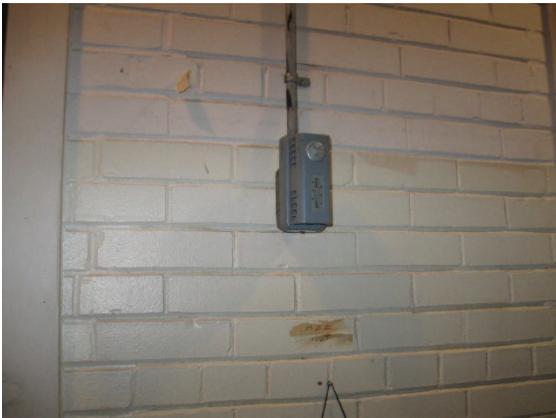
System: C3010 - Wall Finishes

Analysis: The system age is either beyond expected life or does not meet its intended performance under the Guidelines. The system may be in service and functioning but it is recommended to be replaced due to probable increased condition budget needs, the potential failure of its components, or in order to meet the performance Guidelines for this system. The system was installed in 1997. It has a 10-year service life which expired in 2007.

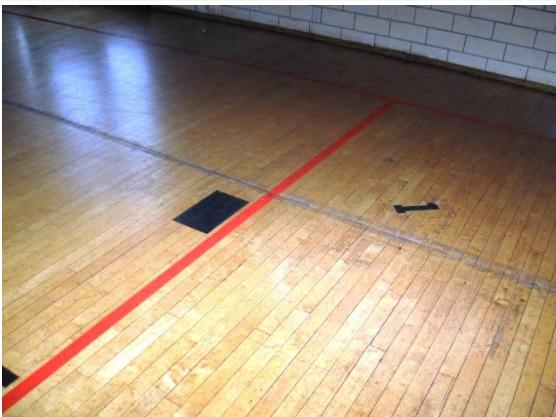
System: C3020 - Floor Finishes

Analysis: The system age is either beyond expected life or does not meet its intended performance under the Guidelines. The system may be in service and functioning but it is recommended to be replaced due to probable increased condition budget needs, the potential failure of its components, or in order to meet the performance Guidelines for this system. The system was installed in 1977. It has a 20-year service life which expired in 1997.

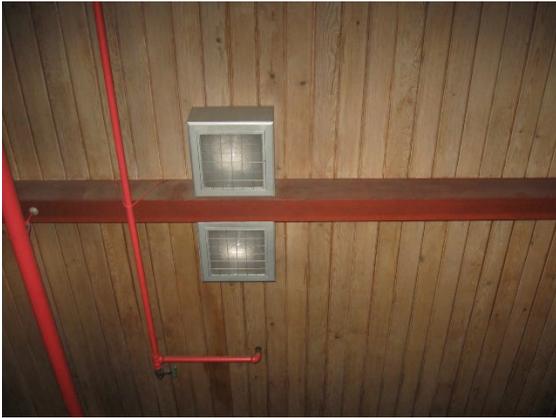
System: C3030 - Ceiling Finishes

Analysis: The system age is either beyond expected life or does not meet its intended performance under the Guidelines. The system may be in service and functioning but it is recommended to be replaced due to probable increased condition budget needs, the potential failure of its components, or in order to meet the performance Guidelines for this system. The system was installed in 1977. It has a 20-year service life which expired in 1997.

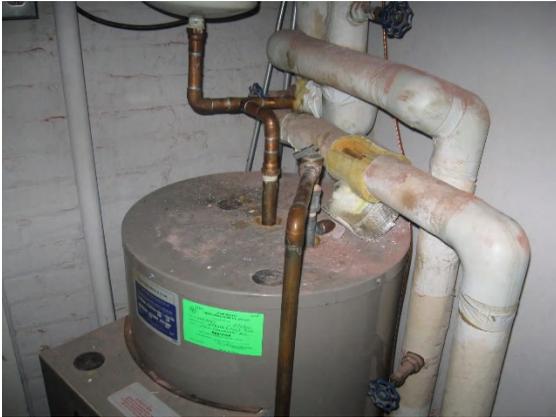
System: D2020 - Domestic Water Distribution

Analysis: The system age is either beyond expected life or does not meet its intended performance under the Guidelines. The system may be in service and functioning but it is recommended to be replaced due to probable increased condition budget needs, the potential failure of its components, or in order to meet the performance Guidelines for this system. The system was installed in 1977. It has a 30-year service life which expired in 2007.

Location: Recreation (Gregory)
Distress: Beyond Expected Life
Category: Deferred Maintenance
Priority: 3 - Necessary- 2-5 Yrs
Correction: Renew System
Qty: 1-Ea.
Condition Budget: \$7,920

Recommendation: The system should be replaced.

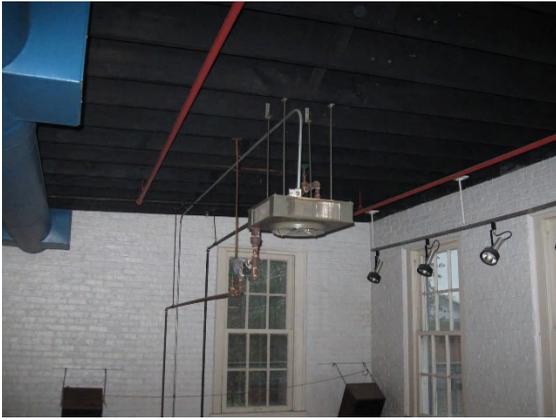
System: D3010 - Energy Supply-Steam Distribution

Analysis: The system age is either beyond expected life or does not meet its intended performance under the Guidelines. The system may be in service and functioning but it is recommended to be replaced due to probable increased condition budget needs, the potential failure of its components, or in order to meet the performance Guidelines for this system. The system was installed in 1977. It has a 30-year service life which expired in 2007.

Recommendation: The system should be replaced.

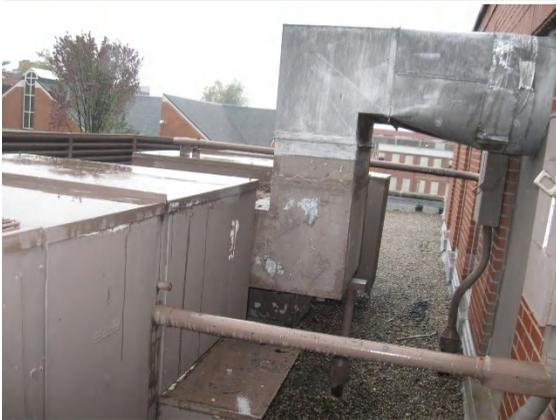
System: D3040 - Distribution Systems

Analysis: The system age is either beyond expected life or does not meet its intended performance under the Guidelines. The system may be in service and functioning but it is recommended to be replaced due to probable increased condition budget needs, the potential failure of its components, or in order to meet the performance Guidelines for this system. The system was installed in 1977. It has a 30-year service life which expired in 2007.

Recommendation: The system should be replaced.

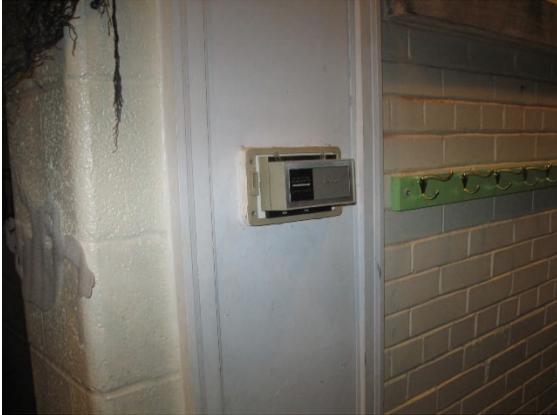
System: D3060 - Controls & Instrumentation

Analysis: The system age is either beyond expected life or does not meet its intended performance under the Guidelines. The system may be in service and functioning but it is recommended to be replaced due to probable increased condition budget needs, the potential failure of its components, or in order to meet the performance Guidelines for this system. The system was installed in 1977. It has a 20-year service life which expired in 1997.

Location: Recreation (Gregory)
Distress: Beyond Expected Life
Category: Deferred Maintenance
Priority: 3 - Necessary- 2-5 Yrs
Correction: Renew System
Qty: 1-Ea.
Condition Budget: \$26,057

Recommendation: The system should be replaced.

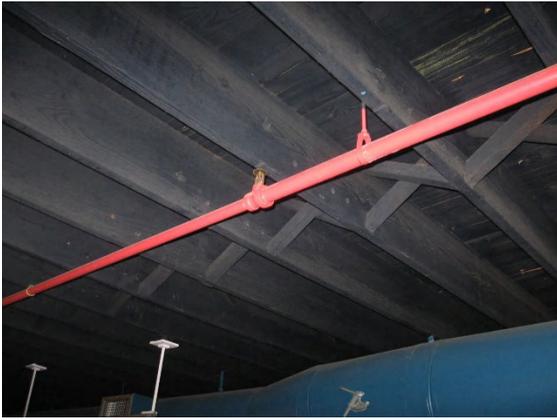
System: D4010 - Sprinklers

Analysis: The system age is either beyond expected life or does not meet its intended performance under the Guidelines. The system may be in service and functioning but it is recommended to be replaced due to probable increased condition budget needs, the potential failure of its components, or in order to meet the performance Guidelines for this system. The system was installed in 1977. It has a 30-year service life which expired in 2007.

Recommendation: The system should be replaced.

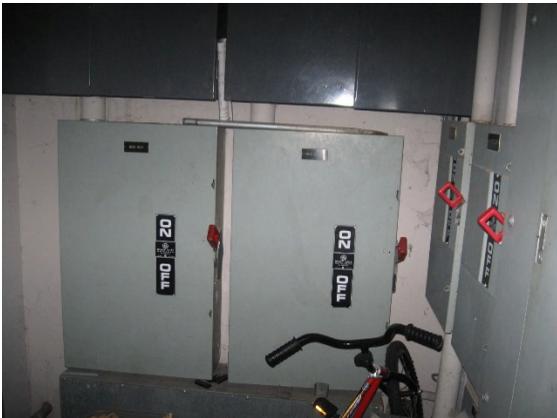
System: D5010 - Electrical Service/Distribution

Analysis: The system age is either beyond expected life or does not meet its intended performance under the Guidelines. The system may be in service and functioning but it is recommended to be replaced due to probable increased condition budget needs, the potential failure of its components, or in order to meet the performance Guidelines for this system. The system was installed in 1977. It has a 30-year service life which expired in 2007.

Recommendation: The system should be replaced.

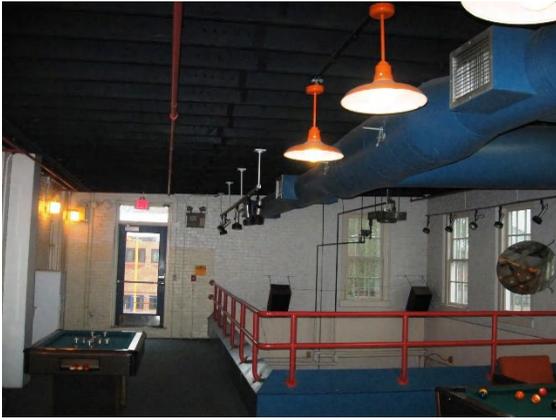
System: D5020 - Lighting and Branch Wiring

Analysis: The system age is either beyond expected life or does not meet its intended performance under the Guidelines. The system may be in service and functioning but it is recommended to be replaced due to probable increased condition budget needs, the potential failure of its components, or in order to meet the performance Guidelines for this system. The system was installed in 1977. It has a 30-year service life which expired in 2007.

Recommendation: The system should be replaced.

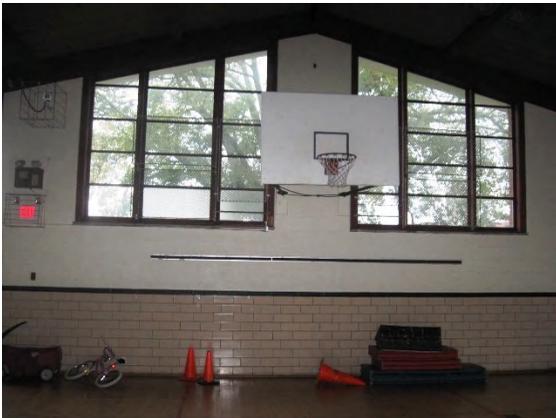
System: E1020 - Institutional Equipment-Athletic Equip

Analysis: The system age is either beyond expected life or does not meet its intended performance under the Guidelines. The system may be in service and functioning but it is recommended to be replaced due to probable increased condition budget needs, the potential failure of its components, or in order to meet the performance Guidelines for this system. The system was installed in 1977. It has a 20-year service life which expired in 1997.

Recommendation: The system should be replaced.

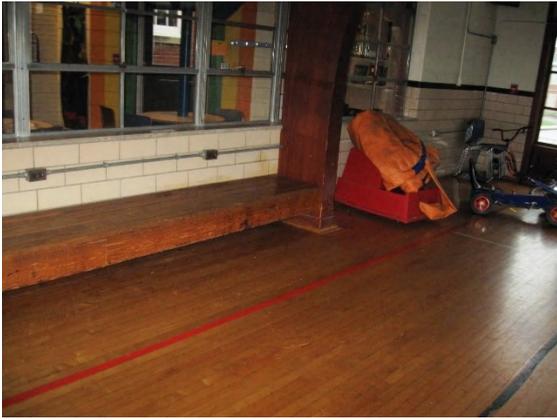
System: E2010 - Fixed Furnishings

Analysis: The system age is either beyond expected life or does not meet its intended performance under the Guidelines. The system may be in service and functioning but it is recommended to be replaced due to probable increased condition budget needs, the potential failure of its components, or in order to meet the performance Guidelines for this system. The system was installed in 1934. It has a 20-year service life which expired in 1954.

Recommendation: The system should be replaced.

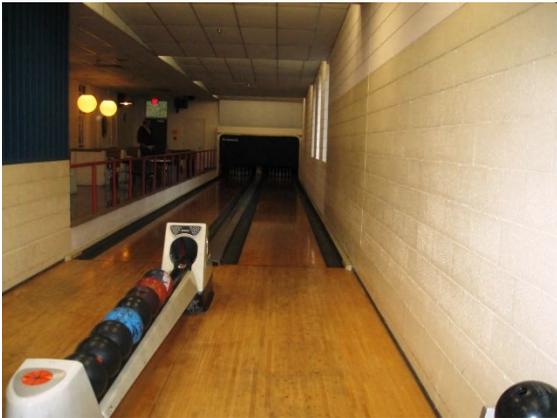
System: F1040 - Special Facilities-Bowling Alley Equip

Analysis: The system age is either beyond expected life or does not meet its intended performance under the Guidelines. The system may be in service and functioning but it is recommended to be replaced due to probable increased condition budget needs, the potential failure of its components, or in order to meet the performance Guidelines for this system. The system was installed in 1977. It has a 30-year service life which expired in 2007.

Recommendation: The system should be replaced.

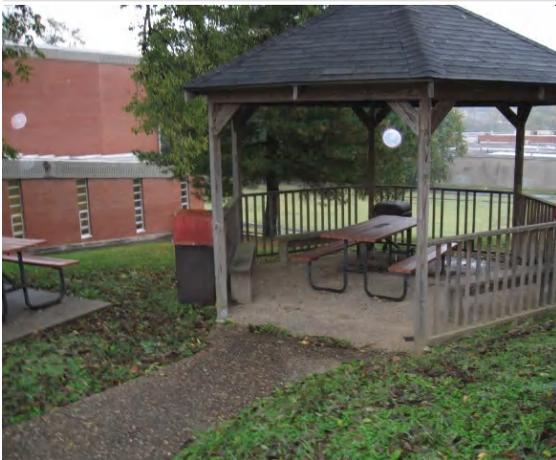
System: G2050 - Landscaping

Analysis: The system age is either beyond expected life or does not meet its intended performance under the Guidelines. The system may be in service and functioning but it is recommended to be replaced due to probable increased condition budget needs, the potential failure of its components, or in order to meet the performance Guidelines for this system. The system was installed in 1977. It has a 20-year service life which expired in 1997.

Recommendation: The system should be replaced.

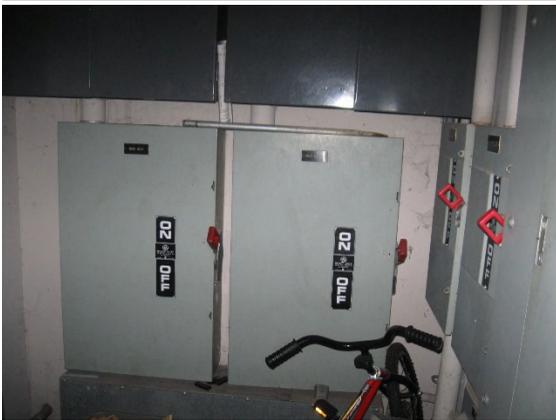
System: G4010 - Electrical Distribution

Analysis: The system age is either beyond expected life or does not meet its intended performance under the Guidelines. The system may be in service and functioning but it is recommended to be replaced due to probable increased condition budget needs, the potential failure of its components, or in order to meet the performance Guidelines for this system. The system was installed in 1977. It has a 30-year service life which expired in 2007.

Location: Recreation (Gregory)
Distress: Beyond Expected Life
Category: Deferred Maintenance
Priority: 3 - Necessary- 2-5 Yrs
Correction: Renew System
Qty: 1-Ea.
Condition Budget: \$13,029

Recommendation: The system should be replaced.

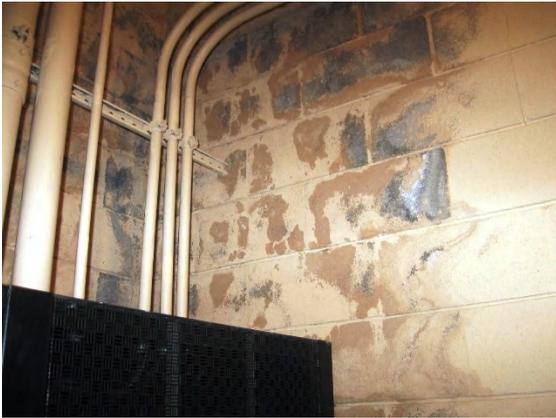
System: B2010 - Exterior Walls

Analysis: The system age is either beyond expected life or does not meet its intended performance under the Guidelines. The system may be in service and functioning but it is recommended to be replaced due to probable increased condition budget needs, the potential failure of its components, or in order to meet the performance Guidelines for this system. The system was installed in 1977. It has a 100-year service life. However, in the assessment, it was found to be currently deficient.

Distress: Damaged

Notes: The exterior walls are reported to leach water thru to interior spaces. The exact cause for this water intrusion was not determined during this KFICS 2011 assessment. However it was reported by KSB facility personnel that the construction detail for the exterior brick and interior CMU walls have inadequate air space between these two building components. It is recommended an engineering study be implemented to determine the exact scope of work to remedy this issue.

Recommendation: The system should be replaced.

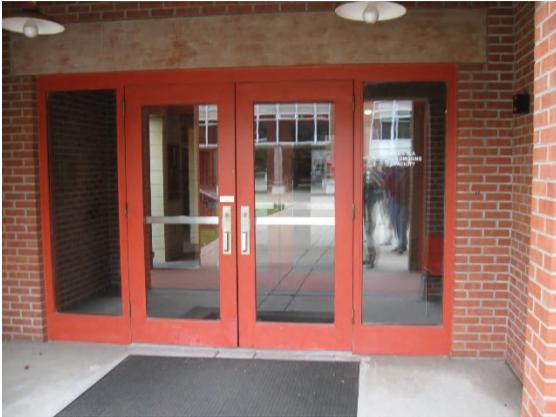
System: B2030 - Exterior Doors

Analysis: The system age is either beyond expected life or does not meet its intended performance under the Guidelines. The system may be in service and functioning but it is recommended to be replaced due to probable increased condition budget needs, the potential failure of its components, or in order to meet the performance Guidelines for this system. The system was installed in 1977. It has a 30-year service life which expired in 2007.

Location: Richie
Distress: Beyond Expected Life
Category: Deferred Maintenance
Priority: 3 - Necessary- 2-5 Yrs
Correction: Renew System
Qty: 1-Ea.
Condition Budget: \$21,344

Recommendation: The system should be replaced.

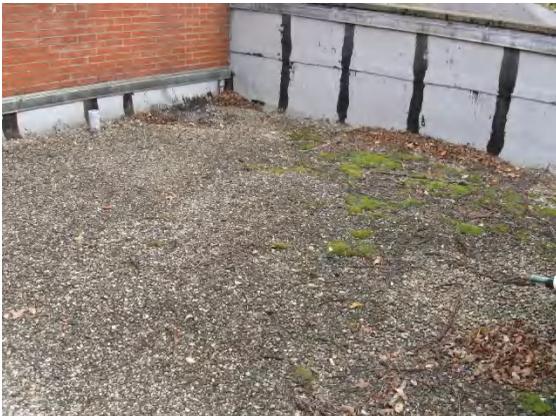
System: B3010 - Roof Coverings

Analysis: The system age is either beyond expected life or does not meet its intended performance under the Guidelines. The system may be in service and functioning but it is recommended to be replaced due to probable increased condition budget needs, the potential failure of its components, or in order to meet the performance Guidelines for this system. The system was installed in 1991. It has a 20-year service life. However, in the assessment, it was found to be currently deficient.

Location: Richie
Distress: Beyond Expected Life
Category: Deferred Maintenance
Priority: 3 - Necessary- 2-5 Yrs
Correction: Renew System
Qty: 1-Ea.
Condition Budget: \$408,758

Recommendation: The system should be replaced.

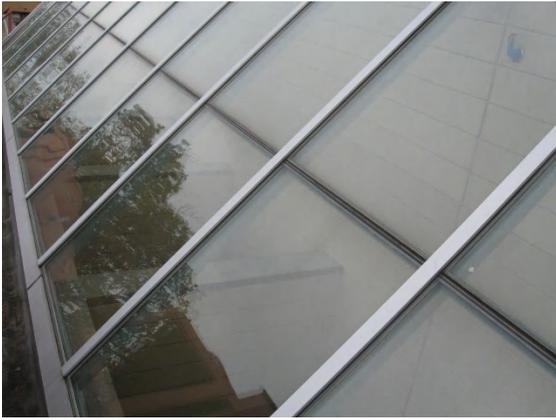
System: B3020 - Roof Openings-Sky Lights

Analysis: The system age is either beyond expected life or does not meet its intended performance under the Guidelines. The system may be in service and functioning but it is recommended to be replaced due to probable increased condition budget needs, the potential failure of its components, or in order to meet the performance Guidelines for this system. The system was installed in 1977. It has a 30-year service life which expired in 2007.

Recommendation: The system should be replaced.

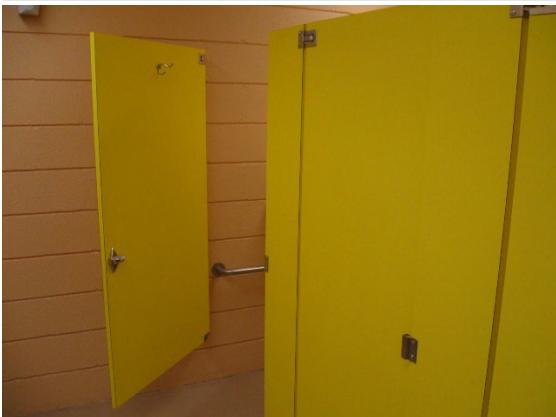
System: C1030 - Fittings

Analysis: The system age is either beyond expected life or does not meet its intended performance under the Guidelines. The system may be in service and functioning but it is recommended to be replaced due to probable increased condition budget needs, the potential failure of its components, or in order to meet the performance Guidelines for this system. The system was installed in 1977. It has a 20-year service life which expired in 1997.

Recommendation: The system should be replaced.

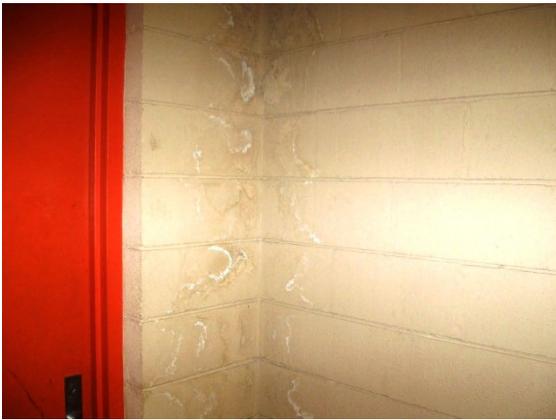
System: C3010 - Wall Finishes

Analysis: The system age is either beyond expected life or does not meet its intended performance under the Guidelines. The system may be in service and functioning but it is recommended to be replaced due to probable increased condition budget needs, the potential failure of its components, or in order to meet the performance Guidelines for this system. The system was installed in 1999. It has a 10-year service life which expired in 2009.

Recommendation: The system should be replaced.

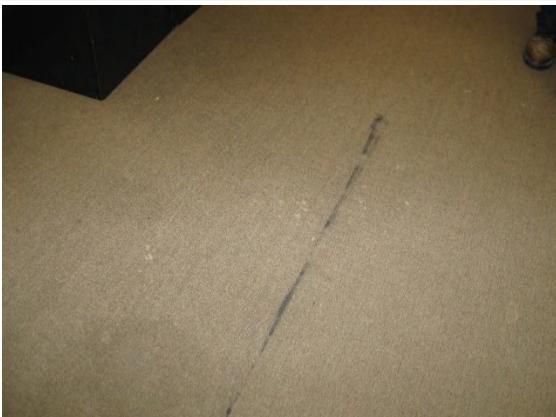
System: C3020 - Floor Finishes

Analysis: The system age is either beyond expected life or does not meet its intended performance under the Guidelines. The system may be in service and functioning but it is recommended to be replaced due to probable increased condition budget needs, the potential failure of its components, or in order to meet the performance Guidelines for this system. The system was installed in 1977. It has a 20-year service life which expired in 1997.

Recommendation: The system should be replaced.

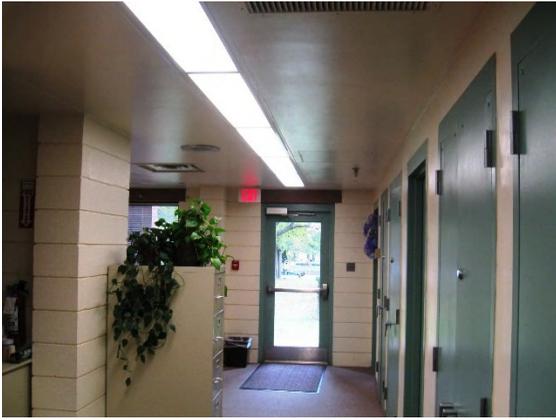
System: C3030 - Ceiling Finishes

Analysis: The system age is either beyond expected life or does not meet its intended performance under the Guidelines. The system may be in service and functioning but it is recommended to be replaced due to probable increased condition budget needs, the potential failure of its components, or in order to meet the performance Guidelines for this system. The system was installed in 1977. It has a 20-year service life which expired in 1997.

Recommendation: The system should be replaced.

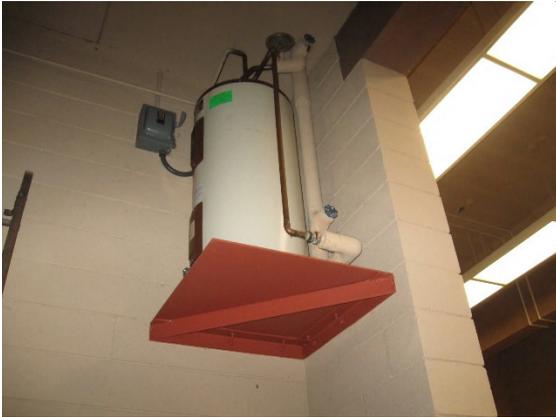
System: D2020 - Domestic Water Distribution

Analysis: The system age is either beyond expected life or does not meet its intended performance under the Guidelines. The system may be in service and functioning but it is recommended to be replaced due to probable increased condition budget needs, the potential failure of its components, or in order to meet the performance Guidelines for this system. The system was installed in 1977. It has a 30-year service life which expired in 2007.

Recommendation: The system should be replaced.

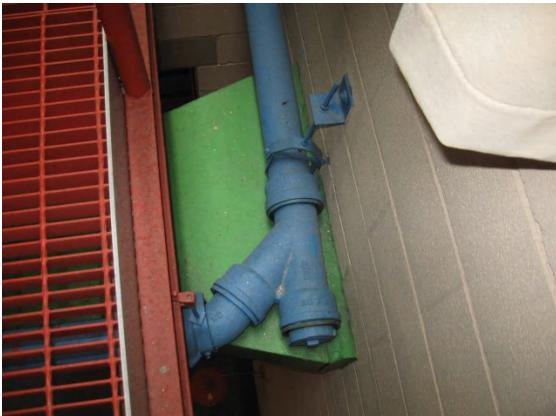
System: D2030 - Sanitary Waste

Analysis: The system age is either beyond expected life or does not meet its intended performance under the Guidelines. The system may be in service and functioning but it is recommended to be replaced due to probable increased condition budget needs, the potential failure of its components, or in order to meet the performance Guidelines for this system. The system was installed in 1977. It has a 30-year service life which expired in 2007.

Recommendation: The system should be replaced.
