School Assessment Report

District: Kentucky School of the Blind

Report: Apr 11, 2012

Condition Assessment: Oct 18, 2011

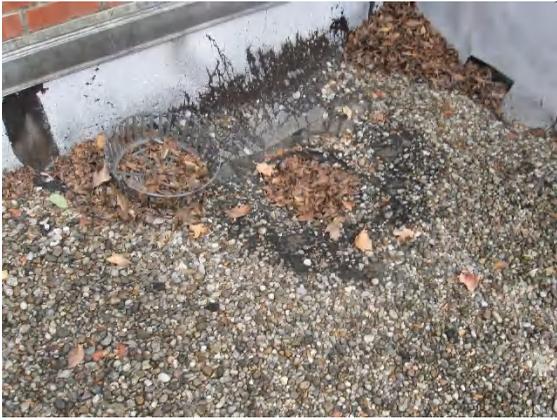
System: D2040 - Rain Water Drainage

Analysis: The system age is either beyond expected life or does not meet its intended performance under the Guidelines. The system may be in service and functioning but it is recommended to be replaced due to probable increased condition budget needs, the potential failure of its components, or in order to meet the performance Guidelines for this system. The system was installed in 1977. It has a 30-year service life which expired in 2007.

Recommendation: The system should be replaced.

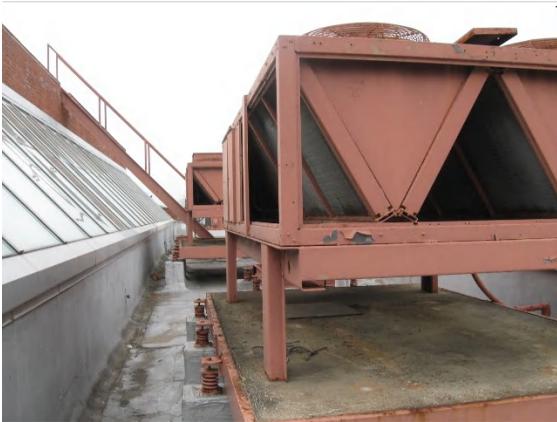
System: D3030 - Cooling Generating Systems

Analysis: The system age is either beyond expected life or does not meet its intended performance under the Guidelines. The system may be in service and functioning but it is recommended to be replaced due to probable increased condition budget needs, the potential failure of its components, or in order to meet the performance Guidelines for this system. The system was installed in 1977. It has a 30-year service life which expired in 2007.

Recommendation: The system should be replaced.

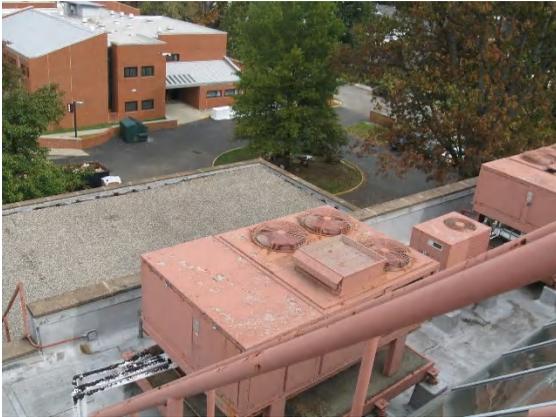
System: D3050 - Terminal & Package Units

Analysis: The system age is either beyond expected life or does not meet its intended performance under the Guidelines. The system may be in service and functioning but it is recommended to be replaced due to probable increased condition budget needs, the potential failure of its components, or in order to meet the performance Guidelines for this system. The system was installed in 1977. It has a 20-year service life which expired in 1997.

Recommendation: The system should be replaced.

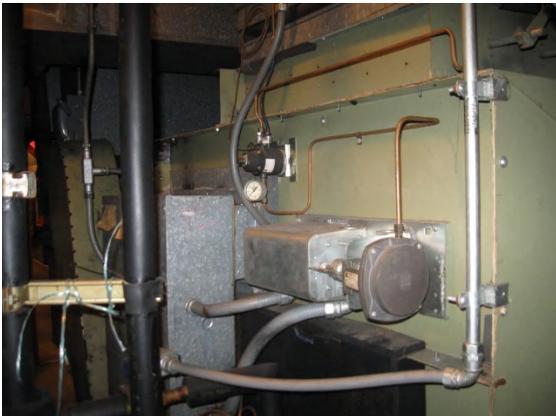
System: D3060 - Controls & Instrumentation

Analysis: The system age is either beyond expected life or does not meet its intended performance under the Guidelines. The system may be in service and functioning but it is recommended to be replaced due to probable increased condition budget needs, the potential failure of its components, or in order to meet the performance Guidelines for this system. The system was installed in 1977. It has a 20-year service life which expired in 1997.

Recommendation: The system should be replaced.

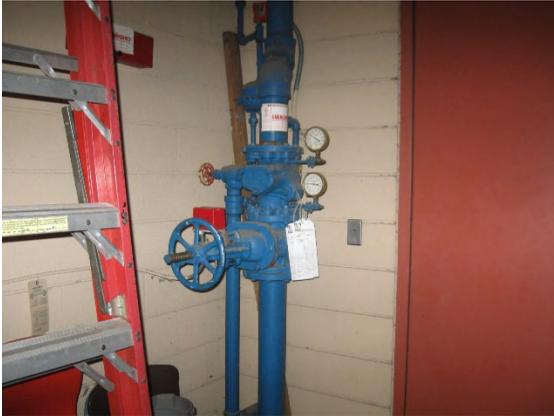
System: D4010 - Sprinklers

Analysis: The system age is either beyond expected life or does not meet its intended performance under the Guidelines. The system may be in service and functioning but it is recommended to be replaced due to probable increased condition budget needs, the potential failure of its components, or in order to meet the performance Guidelines for this system. The system was installed in 1977. It has a 30-year service life which expired in 2007.

Recommendation: The system should be replaced.

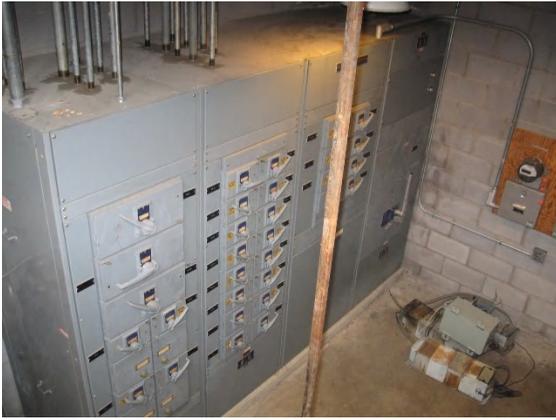
System: D5010 - Electrical Service/Distribution

Analysis: The system age is either beyond expected life or does not meet its intended performance under the Guidelines. The system may be in service and functioning but it is recommended to be replaced due to probable increased condition budget needs, the potential failure of its components, or in order to meet the performance Guidelines for this system. The system was installed in 1977. It has a 30-year service life which expired in 2007.

Recommendation: The system should be replaced.

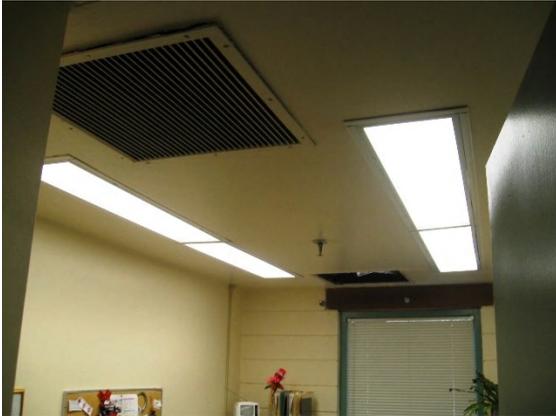
System: D5020 - Lighting and Branch Wiring

Analysis: The system age is either beyond expected life or does not meet its intended performance under the Guidelines. The system may be in service and functioning but it is recommended to be replaced due to probable increased condition budget needs, the potential failure of its components, or in order to meet the performance Guidelines for this system. The system was installed in 1977. It has a 30-year service life which expired in 2007.

Recommendation: The system should be replaced.

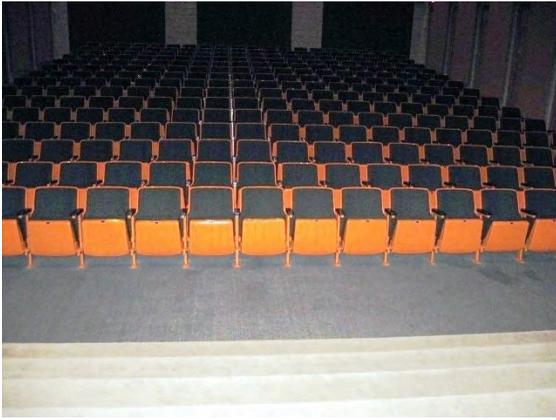
System: E2010 - Fixed Furnishings

Analysis: The system age is either beyond expected life or does not meet its intended performance under the Guidelines. The system may be in service and functioning but it is recommended to be replaced due to probable increased condition budget needs, the potential failure of its components, or in order to meet the performance Guidelines for this system. The system was installed in 1977. It has a 20-year service life which expired in 1997.

Recommendation: The system should be replaced.

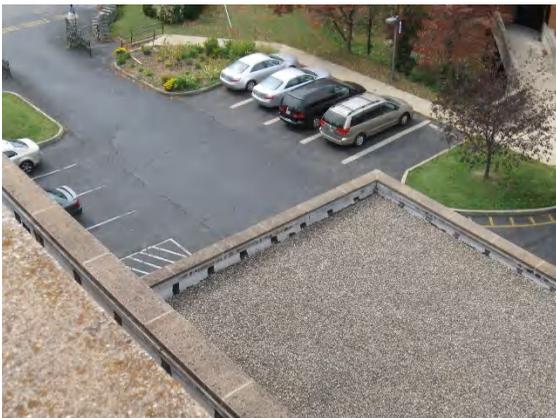
System: G2020 - Parking Lots

Analysis: The system age is either beyond expected life or does not meet its intended performance under the Guidelines. The system may be in service and functioning but it is recommended to be replaced due to probable increased condition budget needs, the potential failure of its components, or in order to meet the performance Guidelines for this system. The system was installed in 1977. It has a 30-year service life which expired in 2007.

Recommendation: The system should be replaced.

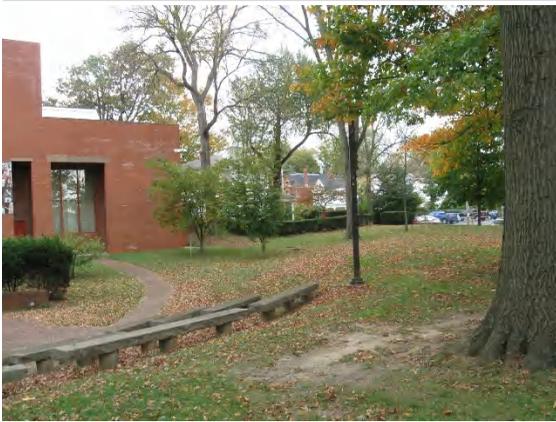
System: G2040 - Site Development

Analysis: The system age is either beyond expected life or does not meet its intended performance under the Guidelines. The system may be in service and functioning but it is recommended to be replaced due to probable increased condition budget needs, the potential failure of its components, or in order to meet the performance Guidelines for this system. The system was installed in 1977. It has a 30-year service life which expired in 2007.

Recommendation: The system should be replaced.

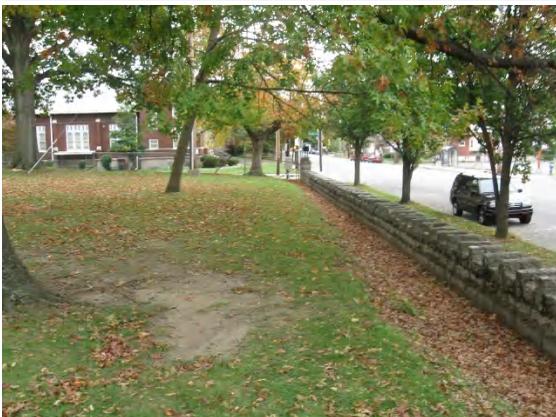
System: G2050 - Landscaping

Analysis: The system age is either beyond expected life or does not meet its intended performance under the Guidelines. The system may be in service and functioning but it is recommended to be replaced due to probable increased condition budget needs, the potential failure of its components, or in order to meet the performance Guidelines for this system. The system was installed in 1977. It has a 20-year service life which expired in 1997.

Recommendation: The system should be replaced.

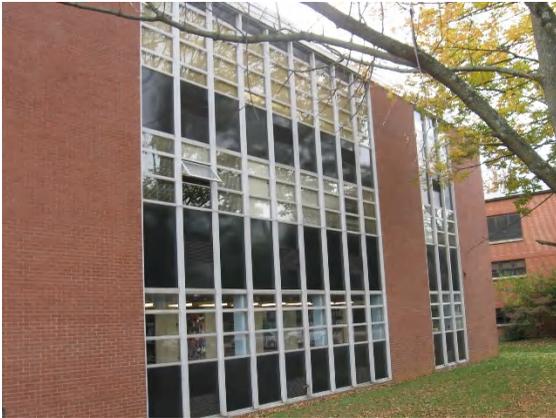
System: B2020 - Exterior Windows

Analysis: The system age is either beyond expected life or does not meet its intended performance under the Guidelines. The system may be in service and functioning but it is recommended to be replaced due to probable increased condition budget needs, the potential failure of its components, or in order to meet the performance Guidelines for this system. The system was installed in 1964. It has a 30-year service life which expired in 1994.

Recommendation: The system should be replaced.

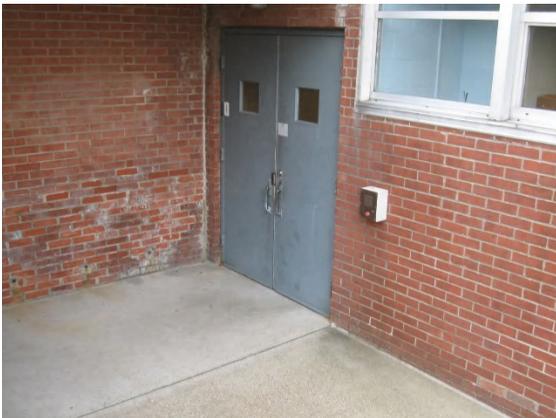
System: B2030 - Exterior Doors

Analysis: The system age is either beyond expected life or does not meet its intended performance under the Guidelines. The system may be in service and functioning but it is recommended to be replaced due to probable increased condition budget needs, the potential failure of its components, or in order to meet the performance Guidelines for this system. The system was installed in 1964. It has a 30-year service life which expired in 1994.

Recommendation: The system should be replaced.

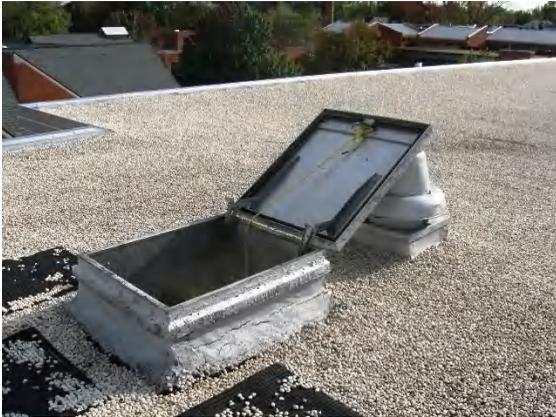
System: B3020 - Roof Openings

Analysis: The system age is either beyond expected life or does not meet its intended performance under the Guidelines. The system may be in service and functioning but it is recommended to be replaced due to probable increased condition budget needs, the potential failure of its components, or in order to meet the performance Guidelines for this system. The system was installed in 1964. It has a 30-year service life which expired in 1994.

Recommendation: The system should be replaced.

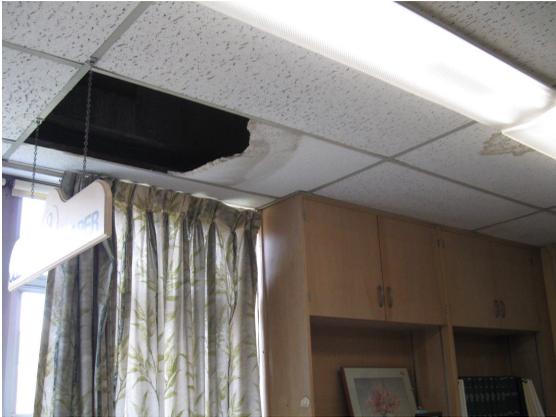
System: C3030 - Ceiling Finishes

Analysis: The system age is either beyond expected life or does not meet its intended performance under the Guidelines. The system may be in service and functioning but it is recommended to be replaced due to probable increased condition budget needs, the potential failure of its components, or in order to meet the performance Guidelines for this system. The system was installed in 1964. It has a 20-year service life which expired in 1984.

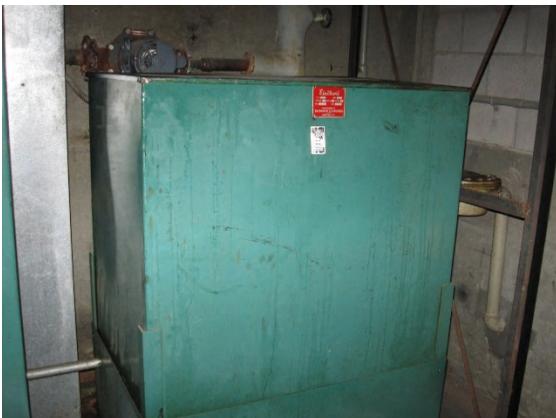
System: D1010 - Elevators and Lifts

Analysis: The system age is either beyond expected life or does not meet its intended performance under the Guidelines. The system may be in service and functioning but it is recommended to be replaced due to probable increased condition budget needs, the potential failure of its components, or in order to meet the performance Guidelines for this system. The system was installed in 1964. It has a 30-year service life which expired in 1994.

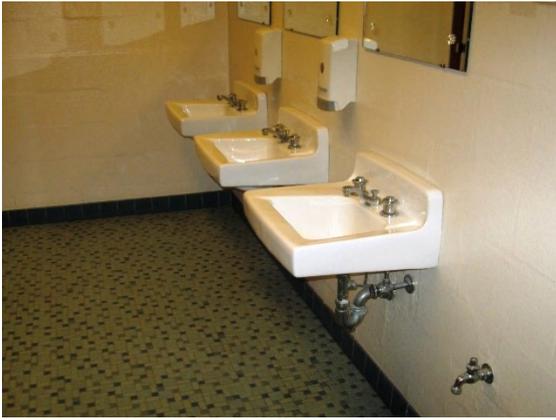
System: D2010 - Plumbing Fixtures

Analysis: The system age is either beyond expected life or does not meet its intended performance under the Guidelines. The system may be in service and functioning but it is recommended to be replaced due to probable increased condition budget needs, the potential failure of its components, or in order to meet the performance Guidelines for this system. The system was installed in 1964. It has a 30-year service life which expired in 1994.

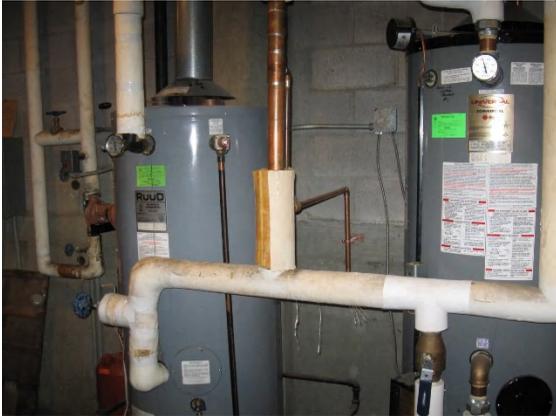
System: D2020 - Domestic Water Distribution

Analysis: The system age is either beyond expected life or does not meet its intended performance under the Guidelines. The system may be in service and functioning but it is recommended to be replaced due to probable increased condition budget needs, the potential failure of its components, or in order to meet the performance Guidelines for this system. The system was installed in 1964. It has a 30-year service life which expired in 1994.

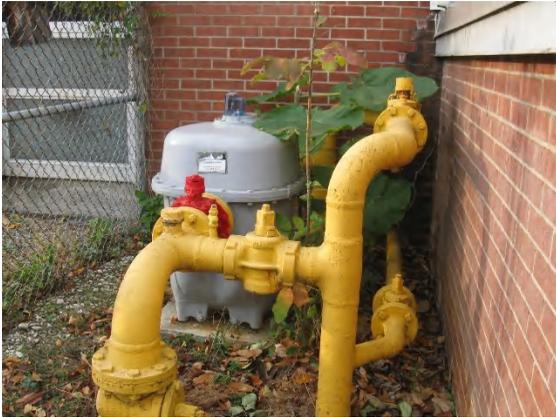
System: D2090 - Other Plumbing Systems-Nat Gas

Analysis: The system age is either beyond expected life or does not meet its intended performance under the Guidelines. The system may be in service and functioning but it is recommended to be replaced due to probable increased condition budget needs, the potential failure of its components, or in order to meet the performance Guidelines for this system. The system was installed in 1964. It has a 20-year service life which expired in 1984.

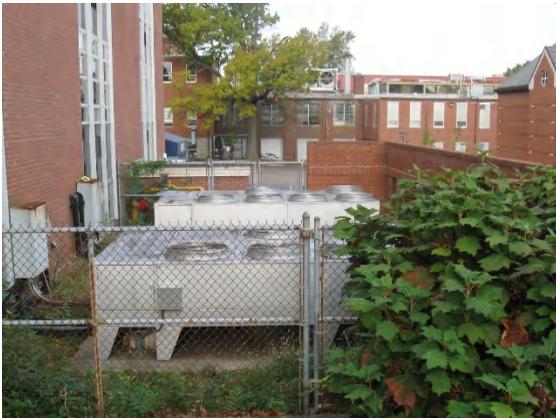
System: D3030 - Cooling Generating Systems

Analysis: The system is in use and functioning but is recommended for renewal within the next 3 – 5 years. The system was installed in 1984. It has a 30-year service life. However, in the assessment, it was found to be currently deficient.

Location: Scoggan Classroom
Distress: Beyond Expected Life
Category: Deferred Maintenance
Priority: 3 - Necessary- 2-5 Yrs
Correction: Renew System
Qty: 1-Ea.
Condition Budget: \$1,317,592

Recommendation: The system should be replaced.

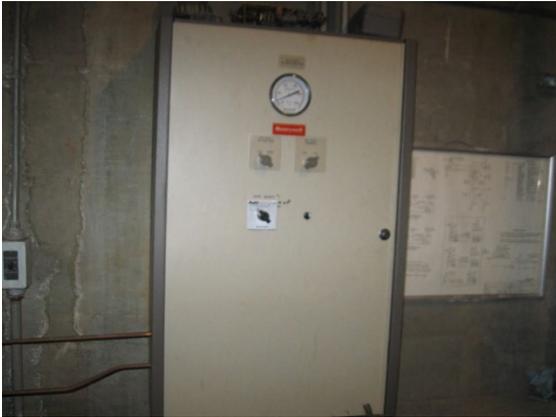
System: D3060 - Controls & Instrumentation

Analysis: The system age is either beyond expected life or does not meet its intended performance under the Guidelines. The system may be in service and functioning but it is recommended to be replaced due to probable increased condition budget needs, the potential failure of its components, or in order to meet the performance Guidelines for this system. The system was installed in 1964. It has a 20-year service life which expired in 1984.

Location: Scoggan Classroom
Distress: Beyond Expected Life
Category: Deferred Maintenance
Priority: 3 - Necessary- 2-5 Yrs
Correction: Renew System
Qty: 1-Ea.
Condition Budget: \$123,878

Recommendation: The system should be replaced.

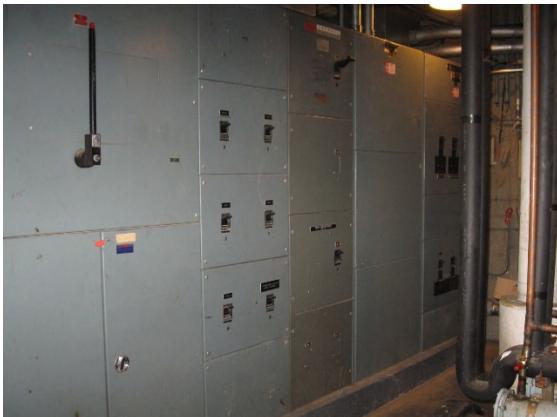
System: D5010 - Electrical Service/Distribution

Analysis: The system is in use and functioning but is recommended for renewal within the next 3 – 5 years. The system was installed in 1984. It has a 30-year service life. However, in the assessment, it was found to be currently deficient.
Recommendation: The system should be replaced.

Location: Scoggan Classroom
Distress: Beyond Expected Life
Category: Deferred Maintenance
Priority: 3 - Necessary- 2-5 Yrs
Notes: The main electrical service located in this building feeds this building plus (4) other campus buildings. The original electrical service and switchgear was installed in 1964 with numerous "add ons" having unique installation dates.
Correction: Renew System
Qty: 1-Ea.
Condition Budget: \$315,130

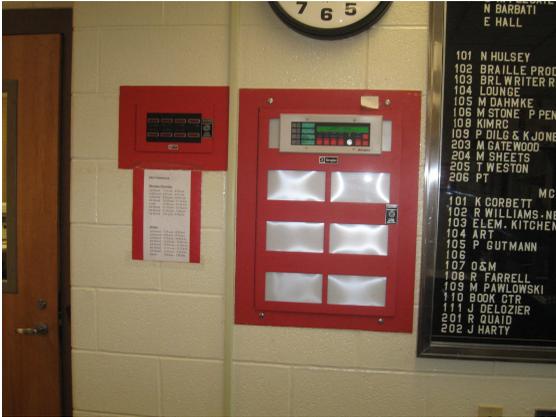
System: D5030 - Communications and Security

Analysis: The system age is either beyond expected life or does not meet its intended performance under the Guidelines. The system may be in service and functioning but it is recommended to be replaced due to probable increased condition budget needs, the potential failure of its components, or in order to meet the performance Guidelines for this system. The system was installed in 1984. It has a 20-year service life which expired in 2004.

Location: Scoggan Classroom
Distress: Beyond Expected Life
Category: Deferred Maintenance
Priority: 3 - Necessary- 2-5 Yrs
Notes: Recommend upgrading and replacing fire alarm, security and telephone systems.
Correction: Renew System
Qty: 1-Ea.
Condition Budget: \$312,820

Recommendation: The system should be replaced.

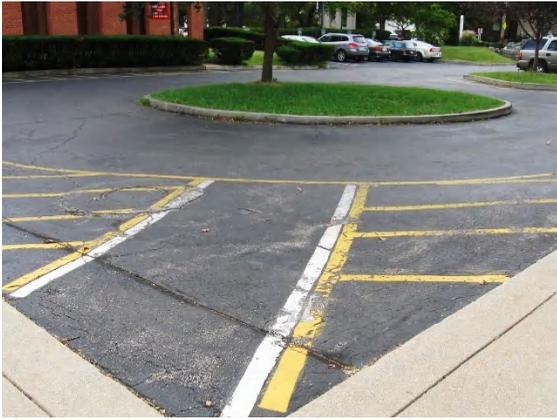
System: G2010 - Roadways

Analysis: The system is in use and functioning but is recommended for renewal within the next 3 – 5 years. The system was installed in 1964. It has a 50-year service life. However, in the assessment, it was found to be currently deficient.

Recommendation: The system should be replaced.

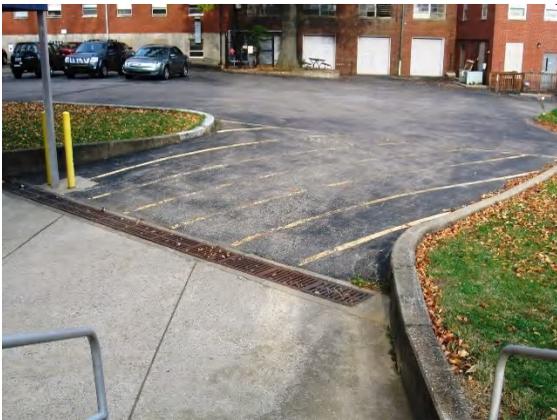
System: G2020 - Parking Lots

Analysis: The system age is either beyond expected life or does not meet its intended performance under the Guidelines. The system may be in service and functioning but it is recommended to be replaced due to probable increased condition budget needs, the potential failure of its components, or in order to meet the performance Guidelines for this system. The system was installed in 1964. It has a 30-year service life which expired in 1994.

Recommendation: The system should be replaced.

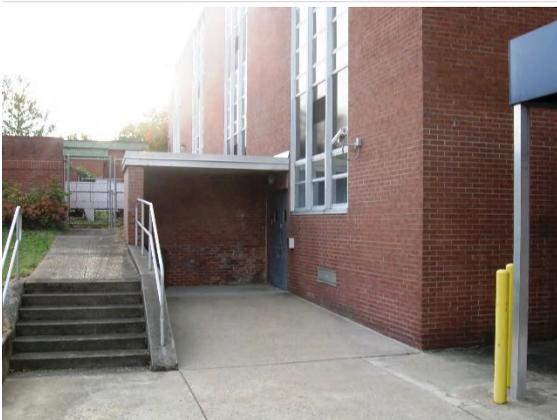
System: G2030 - Pedestrian Paving

Analysis: The system is in use and functioning but is recommended for renewal within the next 3 – 5 years. The system was installed in 1964. It has a 50-year service life. However, in the assessment, it was found to be currently deficient.

Recommendation: The system should be replaced.

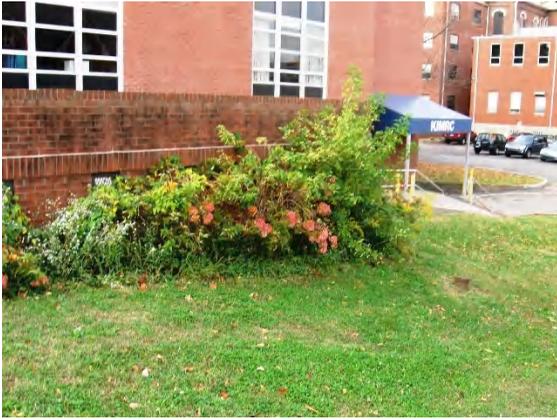
System: G2040 - Site Development

Analysis: The system age is either beyond expected life or does not meet its intended performance under the Guidelines. The system may be in service and functioning but it is recommended to be replaced due to probable increased condition budget needs, the potential failure of its components, or in order to meet the performance Guidelines for this system. The system was installed in 1964. It has a 30-year service life which expired in 1994.

Recommendation: The system should be replaced.

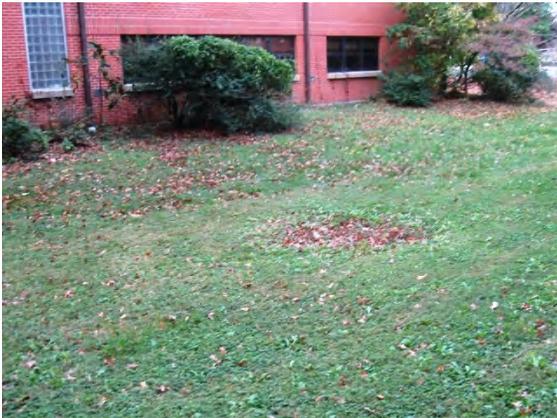
System: G2050 - Landscaping

Analysis: The system age is either beyond expected life or does not meet its intended performance under the Guidelines. The system may be in service and functioning but it is recommended to be replaced due to probable increased condition budget needs, the potential failure of its components, or in order to meet the performance Guidelines for this system. The system was installed in 1964. It has a 20-year service life which expired in 1984.

Recommendation: The system should be replaced.

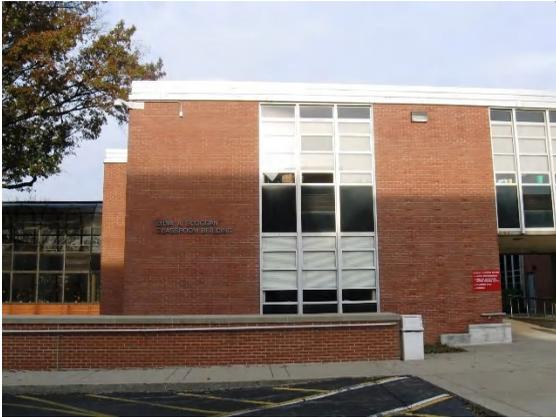
System: G4020 - Site Lighting
Analysis: The system is missing.
Recommendation: The system should be installed.
