School Assessment Report

District: Kentucky School of the Deaf

Report: Apr 11, 2012

Condition Assessment: Nov 18, 2011

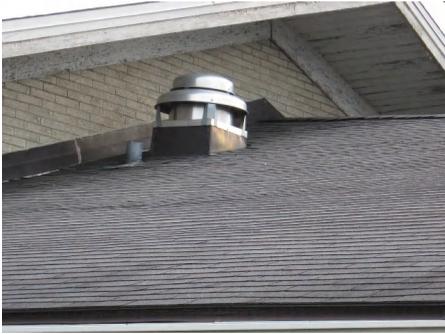
Analysis: The system age is either beyond expected life or does not meet its intended performance under the Guidelines. The system may be in service and functioning but it is recommended to be replaced due to probable increased condition budget needs, the potential failure of its components, or in order to meet the performance Guidelines for this system. The system was installed in 1984. It has a 20-year service life which expired in 2004.

Notes: Roof leaks are reported. Gutters and downspouts need repair and/or replacement with roof replacement.

Recommendation: The system should be replaced.

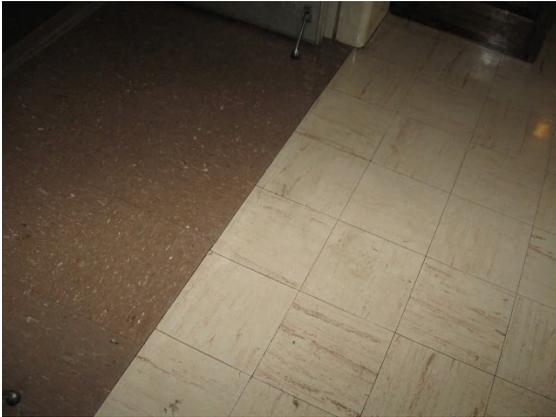
System: C3020 - Floor Finishes

Analysis: The system age is either beyond expected life or does not meet its intended performance under the Guidelines. The system may be in service and functioning but it is recommended to be replaced due to probable increased condition budget needs, the potential failure of its components, or in order to meet the performance Guidelines for this system. The system was installed in 1964. It has a 20-year service life which expired in 1984.

Recommendation: The system should be replaced.

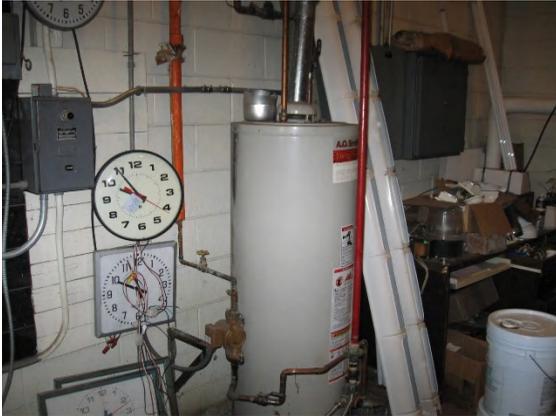
System: D2020 - Domestic Water Distribution

Analysis: The system age is either beyond expected life or does not meet its intended performance under the Guidelines. The system may be in service and functioning but it is recommended to be replaced due to probable increased condition budget needs, the potential failure of its components, or in order to meet the performance Guidelines for this system. The system was installed in 1964. It has a 30-year service life which expired in 1994.

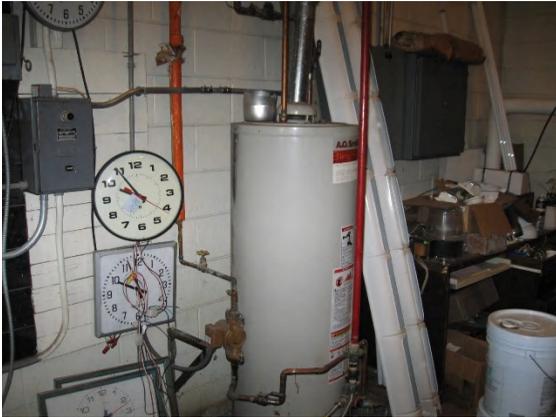
System: D2090 - Other Plumbing Systems-Nat Gas

Analysis: The system age is either beyond expected life or does not meet its intended performance under the Guidelines. The system may be in service and functioning but it is recommended to be replaced due to probable increased condition budget needs, the potential failure of its components, or in order to meet the performance Guidelines for this system. The system was installed in 1964. It has a 20-year service life which expired in 1984.

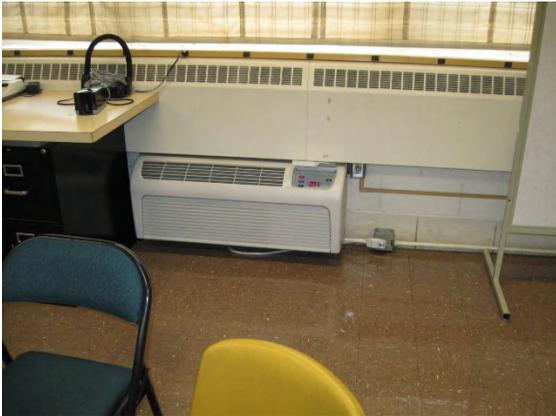
System: D3050 - Terminal & Package Units

Analysis: The system age is either beyond expected life or does not meet its intended performance under the Guidelines. The system may be in service and functioning but it is recommended to be replaced due to probable increased condition budget needs, the potential failure of its components, or in order to meet the performance Guidelines for this system. The system was installed in 1964. It has a 15-year service life which expired in 1979.

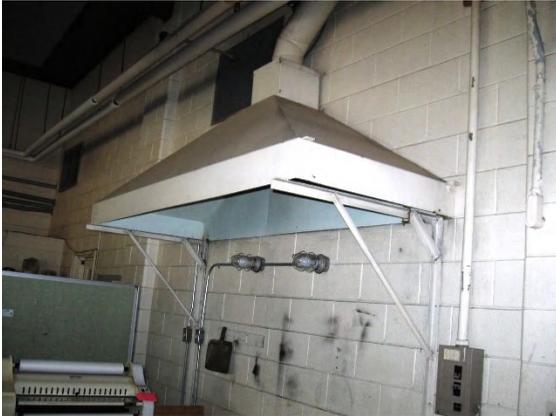
System: D3090 - Other HVAC Systems/Equip

Analysis: The system age is either beyond expected life or does not meet its intended performance under the Guidelines. The system may be in service and functioning but it is recommended to be replaced due to probable increased condition budget needs, the potential failure of its components, or in order to meet the performance Guidelines for this system. The system was installed in 1964. It has a 30-year service life which expired in 1994.

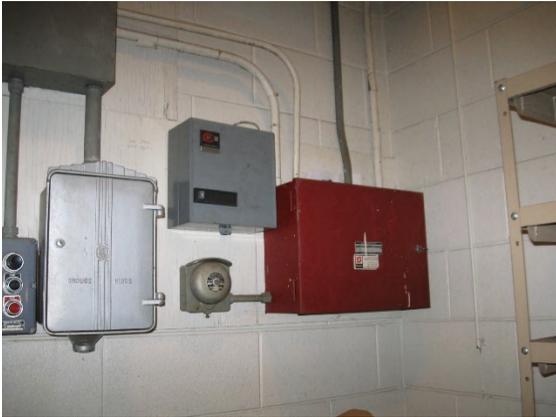
System: D5030 - Communications and Security

Analysis: The system age is either beyond expected life or does not meet its intended performance under the Guidelines. The system may be in service and functioning but it is recommended to be replaced due to probable increased condition budget needs, the potential failure of its components, or in order to meet the performance Guidelines for this system. The system was installed in 1964. It has a 20-year service life which expired in 1984.

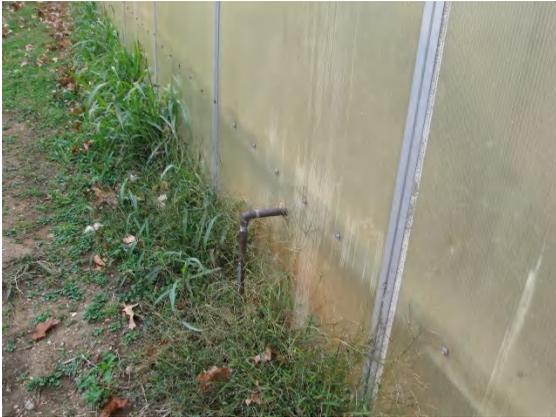
System: G3010 - Water Supply

Analysis: The system is in use and functioning but is recommended for renewal within the next 3 – 5 years. The system was installed in 1964. It has a 50-year service life. However, in the assessment, it was found to be currently deficient.

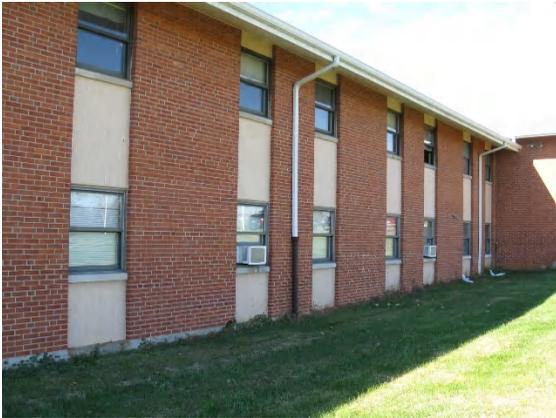
System: B2020 - Exterior Windows

Analysis: The system age is either beyond expected life or does not meet its intended performance under the Guidelines. The system may be in service and functioning but it is recommended to be replaced due to probable increased condition budget needs, the potential failure of its components, or in order to meet the performance Guidelines for this system. The system was installed in 1966. It has a 30-year service life which expired in 1996.

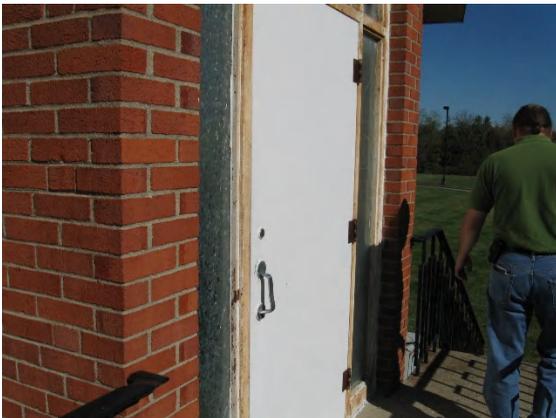
System: B2030 - Exterior Doors

Analysis: The system age is either beyond expected life or does not meet its intended performance under the Guidelines. The system may be in service and functioning but it is recommended to be replaced due to probable increased condition budget needs, the potential failure of its components, or in order to meet the performance Guidelines for this system. The system was installed in 1980. It has a 30-year service life which expired in 2010.

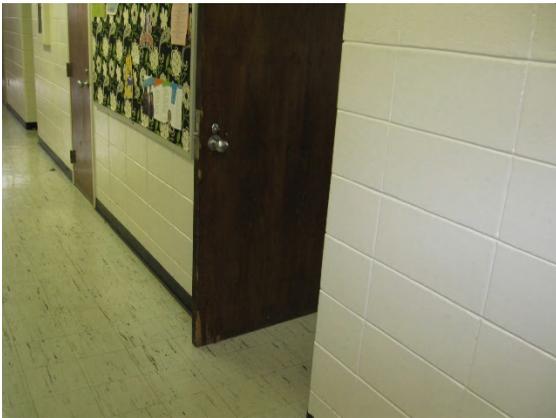
System: C1020 - Interior Doors

Analysis: The system age is either beyond expected life or does not meet its intended performance under the Guidelines. The system may be in service and functioning but it is recommended to be replaced due to probable increased condition budget needs, the potential failure of its components, or in order to meet the performance Guidelines for this system. The system was installed in 1966. It has a 40-year service life which expired in 2006.

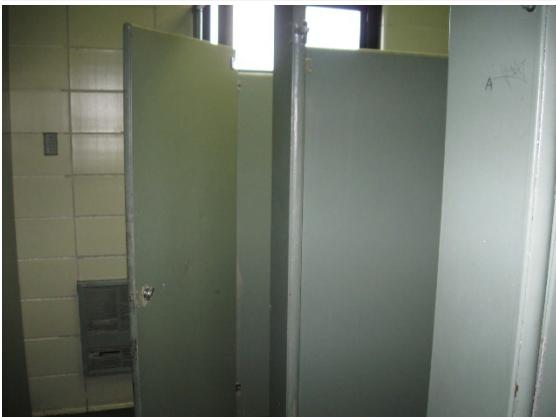
System: C1030 - Fittings

Analysis: The system age is either beyond expected life or does not meet its intended performance under the Guidelines. The system may be in service and functioning but it is recommended to be replaced due to probable increased condition budget needs, the potential failure of its components, or in order to meet the performance Guidelines for this system. The system was installed in 1980. It has a 20-year service life which expired in 2000.

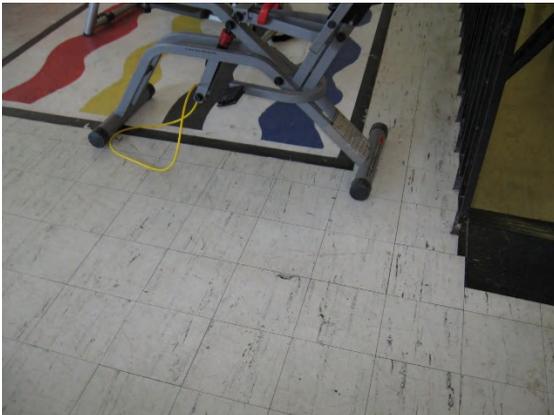
System: C3020 - Floor Finishes

Analysis: The system age is either beyond expected life or does not meet its intended performance under the Guidelines. The system may be in service and functioning but it is recommended to be replaced due to probable increased condition budget needs, the potential failure of its components, or in order to meet the performance Guidelines for this system. The system was installed in 1980. It has a 20-year service life which expired in 2000.

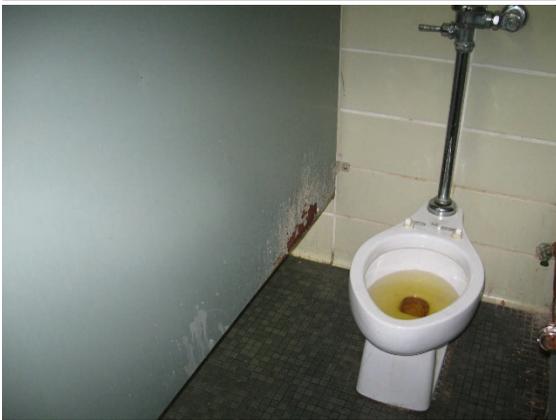
System: D2010 - Plumbing Fixtures

Analysis: The system age is either beyond expected life or does not meet its intended performance under the Guidelines. The system may be in service and functioning but it is recommended to be replaced due to probable increased condition budget needs, the potential failure of its components, or in order to meet the performance Guidelines for this system. The system was installed in 1966. It has a 30-year service life which expired in 1996.

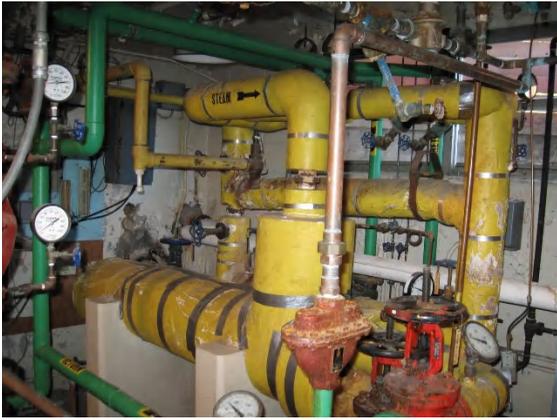
System: D3010 - Energy Supply

Analysis: The system age is either beyond expected life or does not meet its intended performance under the Guidelines. The system may be in service and functioning but it is recommended to be replaced due to probable increased condition budget needs, the potential failure of its components, or in order to meet the performance Guidelines for this system. The system was installed in 1980. It has a 30-year service life which expired in 2010.

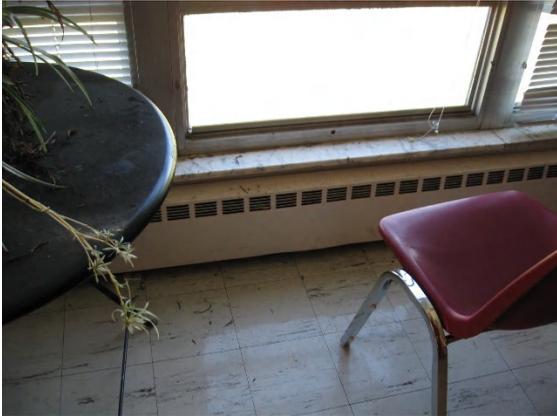
System: D3040 - Distribution Systems

Analysis: The system age is either beyond expected life or does not meet its intended performance under the Guidelines. The system may be in service and functioning but it is recommended to be replaced due to probable increased condition budget needs, the potential failure of its components, or in order to meet the performance Guidelines for this system. The system was installed in 1980. It has a 30-year service life which expired in 2010.

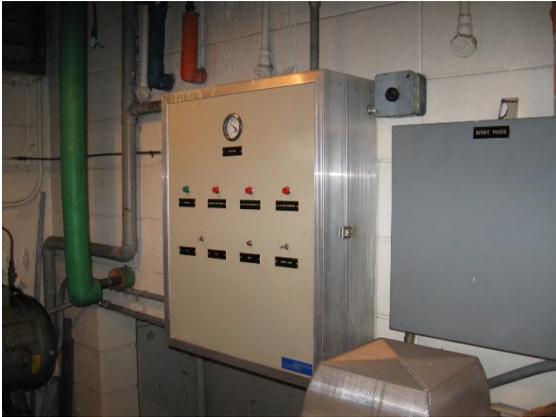
System: D3060 - Controls & Instrumentation

Analysis: The system age is either beyond expected life or does not meet its intended performance under the Guidelines. The system may be in service and functioning but it is recommended to be replaced due to probable increased condition budget needs, the potential failure of its components, or in order to meet the performance Guidelines for this system. The system was installed in 1980. It has a 20-year service life which expired in 2000.

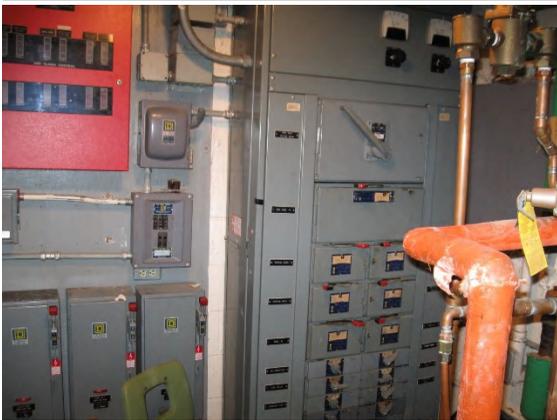
System: D5010 - Electrical Service/Distribution

Analysis: The system age is either beyond expected life or does not meet its intended performance under the Guidelines. The system may be in service and functioning but it is recommended to be replaced due to probable increased condition budget needs, the potential failure of its components, or in order to meet the performance Guidelines for this system. The system was installed in 1980. It has a 30-year service life which expired in 2010.

Location: Bruce Hall
Distress: Beyond Expected Life
Category: Deferred Maintenance
Priority: 3 - Necessary- 2-5 Yrs
Correction: Renew System
Qty: 1-Ea.
Condition Budget: \$49,947

Recommendation: The system should be replaced.

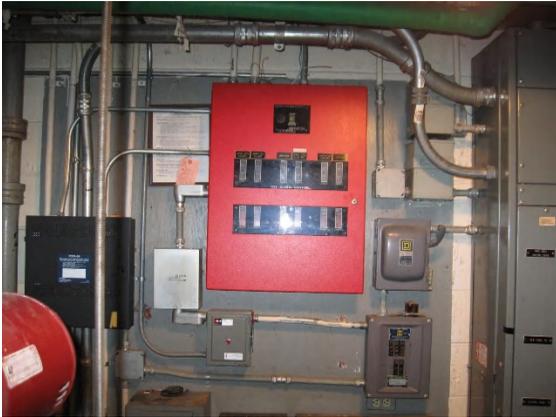
System: D5030 - Communications and Security

Analysis: The system age is either beyond expected life or does not meet its intended performance under the Guidelines. The system may be in service and functioning but it is recommended to be replaced due to probable increased condition budget needs, the potential failure of its components, or in order to meet the performance Guidelines for this system. The system was installed in 1980. It has a 20-year service life which expired in 2000.

Location: Bruce Hall
Distress: Beyond Expected Life
Category: Deferred Maintenance
Priority: 3 - Necessary- 2-5 Yrs
Correction: Renew System
Qty: 1-Ea.
Condition Budget: \$83,077

Recommendation: The system should be replaced.

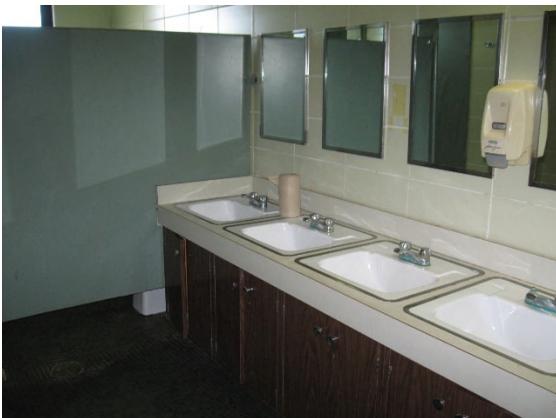
System: E2010 - Fixed Furnishings

Analysis: The system age is either beyond expected life or does not meet its intended performance under the Guidelines. The system may be in service and functioning but it is recommended to be replaced due to probable increased condition budget needs, the potential failure of its components, or in order to meet the performance Guidelines for this system. The system was installed in 1966. It has a 20-year service life which expired in 1986.

Location: Bruce Hall
Distress: Beyond Expected Life
Category: Deferred Maintenance
Priority: 3 - Necessary- 2-5 Yrs
Correction: Renew System
Qty: 1-Ea.
Condition Budget: \$71,316

Recommendation: The system should be replaced.

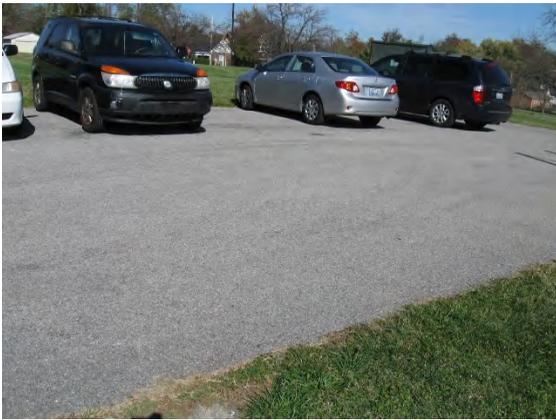
System: G2020 - Parking Lots

Analysis: The system age is either beyond expected life or does not meet its intended performance under the Guidelines. The system may be in service and functioning but it is recommended to be replaced due to probable increased condition budget needs, the potential failure of its components, or in order to meet the performance Guidelines for this system. The system was installed in 1980. It has a 30-year service life which expired in 2010.

Recommendation: The system should be replaced.

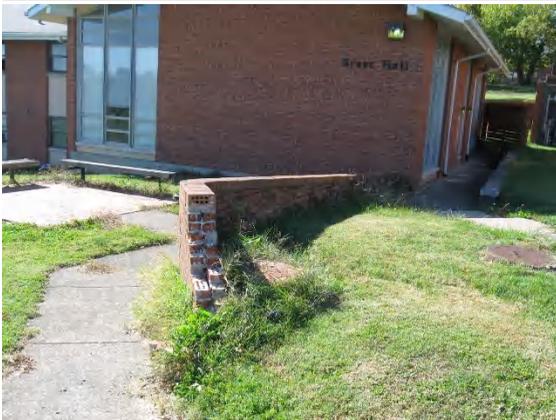
System: G2050 - Landscaping

Analysis: The system age is either beyond expected life or does not meet its intended performance under the Guidelines. The system may be in service and functioning but it is recommended to be replaced due to probable increased condition budget needs, the potential failure of its components, or in order to meet the performance Guidelines for this system. The system was installed in 1980. It has a 20-year service life which expired in 2000.

Location: Bruce Hall
Distress: Beyond Expected Life
Category: Deferred Maintenance
Priority: 3 - Necessary- 2-5 Yrs
Correction: Renew System
Qty: 1-Ea.
Condition Budget: \$12,917

Recommendation: The system should be replaced.

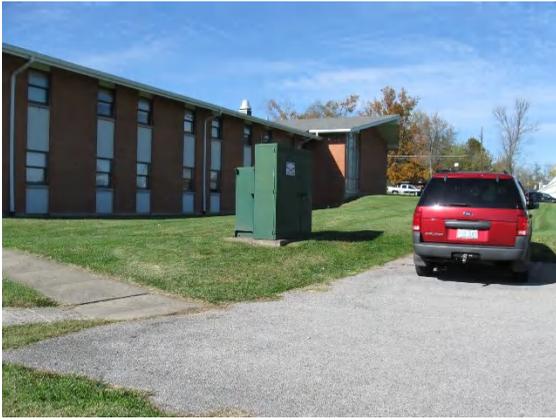
System: G4010 - Electrical Distribution

Analysis: The system age is either beyond expected life or does not meet its intended performance under the Guidelines. The system may be in service and functioning but it is recommended to be replaced due to probable increased condition budget needs, the potential failure of its components, or in order to meet the performance Guidelines for this system. The system was installed in 1980. It has a 30-year service life which expired in 2010.

Recommendation: The system should be replaced.

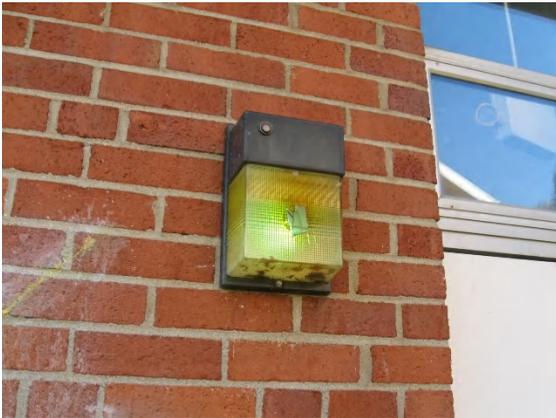
System: G4020 - Site Lighting

Analysis: The system age is either beyond expected life or does not meet its intended performance under the Guidelines. The system may be in service and functioning but it is recommended to be replaced due to probable increased condition budget needs, the potential failure of its components, or in order to meet the performance Guidelines for this system. The system was installed in 1980. It has a 30-year service life which expired in 2010.

Distress: Inadequate

Notes: Recommend adding site lighting for security and safe pedestrian travel.

Recommendation: The system should be replaced.

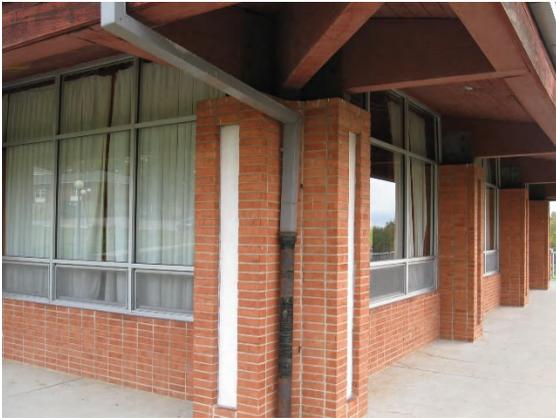
System: B2020 - Exterior Windows

Analysis: The system age is either beyond expected life or does not meet its intended performance under the Guidelines. The system may be in service and functioning but it is recommended to be replaced due to probable increased condition budget needs, the potential failure of its components, or in order to meet the performance Guidelines for this system. The system was installed in 1968. It has a 30-year service life which expired in 1998.

Recommendation: The system should be replaced.

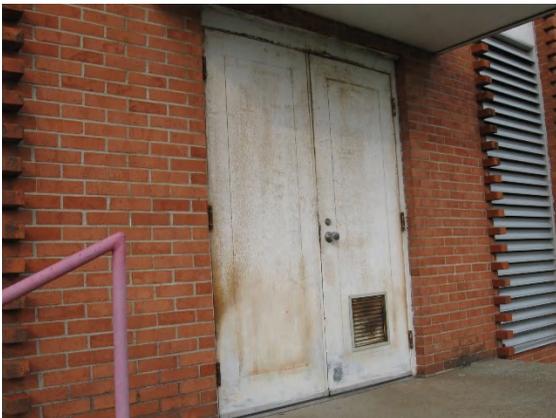
System: B2030 - Exterior Doors

Analysis: The system age is either beyond expected life or does not meet its intended performance under the Guidelines. The system may be in service and functioning but it is recommended to be replaced due to probable increased condition budget needs, the potential failure of its components, or in order to meet the performance Guidelines for this system. The system was installed in 1968. It has a 30-year service life which expired in 1998.

Recommendation: The system should be replaced.

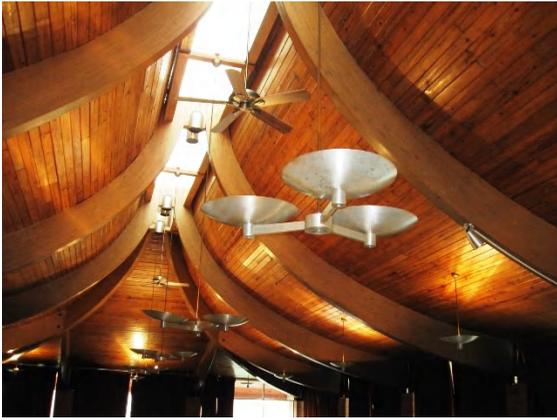
System: B3020 - Roof Openings

Analysis: The system age is either beyond expected life or does not meet its intended performance under the Guidelines. The system may be in service and functioning but it is recommended to be replaced due to probable increased condition budget needs, the potential failure of its components, or in order to meet the performance Guidelines for this system. The system was installed in 1968. It has a 30-year service life which expired in 1998.

Notes: The roof skylights were not inspected during this 2011 assessment but are believed to be original to the building construction date of 1968 and therefore beyond expected life. The openings are recommended to be included in the capital budget planning budget.

Recommendation: The system should be replaced.

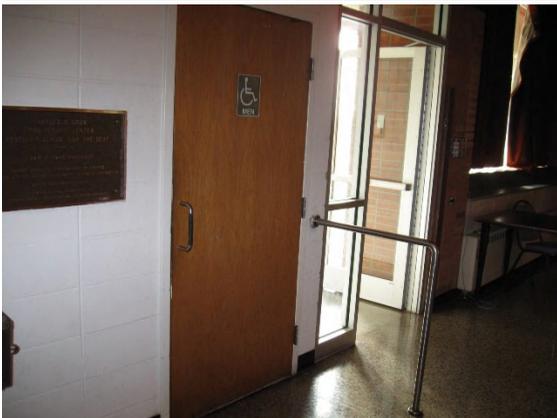
System: C1020 - Interior Doors

Analysis: The system age is either beyond expected life or does not meet its intended performance under the Guidelines. The system may be in service and functioning but it is recommended to be replaced due to probable increased condition budget needs, the potential failure of its components, or in order to meet the performance Guidelines for this system. The system was installed in 1968. It has a 40-year service life which expired in 2008.

Recommendation: The system should be replaced.

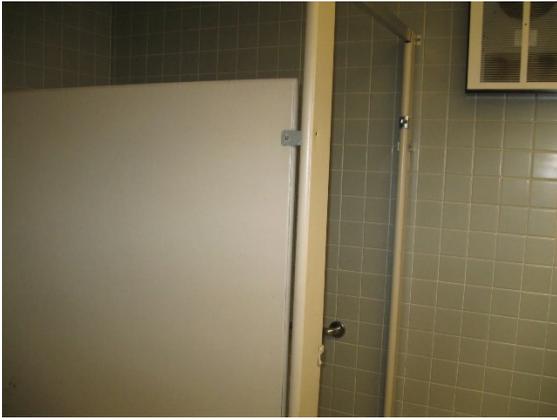
System: C1030 - Fittings

Analysis: The system age is either beyond expected life or does not meet its intended performance under the Guidelines. The system may be in service and functioning but it is recommended to be replaced due to probable increased condition budget needs, the potential failure of its components, or in order to meet the performance Guidelines for this system. The system was installed in 1968. It has a 20-year service life which expired in 1988.

Recommendation: The system should be replaced.

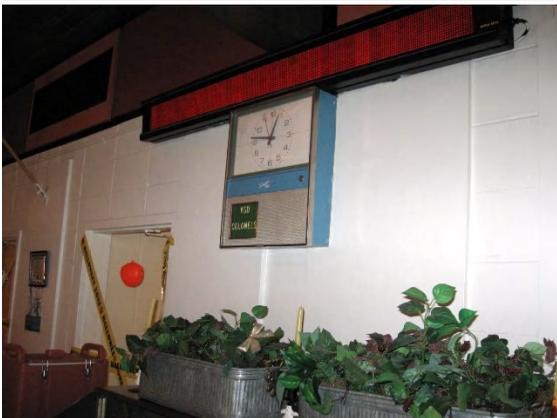
System: C3010 - Wall Finishes

Analysis: The system age is either beyond expected life or does not meet its intended performance under the Guidelines. The system may be in service and functioning but it is recommended to be replaced due to probable increased condition budget needs, the potential failure of its components, or in order to meet the performance Guidelines for this system. The system was installed in 2000. It has a 10-year service life which expired in 2010.

Recommendation: The system should be replaced.

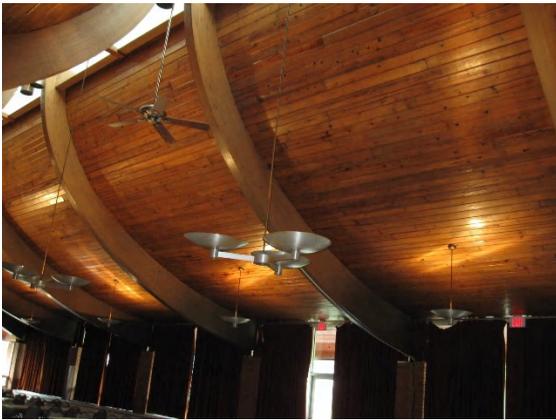
System: C3030 - Ceiling Finishes

Analysis: The system age is either beyond expected life or does not meet its intended performance under the Guidelines. The system may be in service and functioning but it is recommended to be replaced due to probable increased condition budget needs, the potential failure of its components, or in order to meet the performance Guidelines for this system. The system was installed in 1968. It has a 20-year service life which expired in 1988.

Recommendation: The system should be replaced.

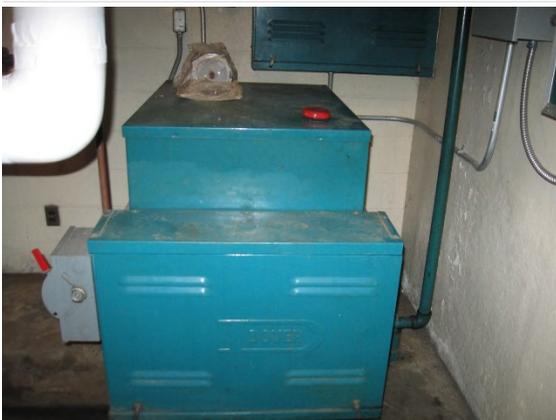
System: D1010 - Elevators and Lifts

Analysis: The system age is either beyond expected life or does not meet its intended performance under the Guidelines. The system may be in service and functioning but it is recommended to be replaced due to probable increased condition budget needs, the potential failure of its components, or in order to meet the performance Guidelines for this system. The system was installed in 1980. It has a 30-year service life which expired in 2010.

Recommendation: The system should be replaced.

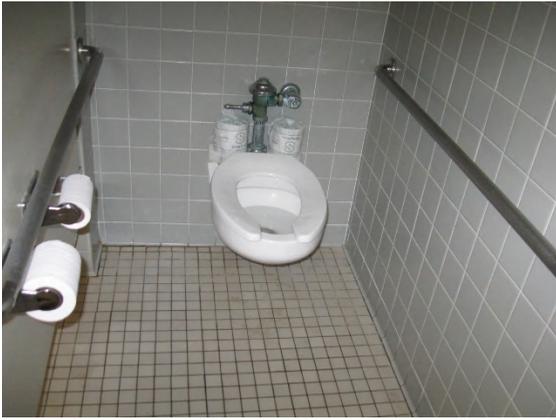
System: D2010 - Plumbing Fixtures

Analysis: The system age is either beyond expected life or does not meet its intended performance under the Guidelines. The system may be in service and functioning but it is recommended to be replaced due to probable increased condition budget needs, the potential failure of its components, or in order to meet the performance Guidelines for this system. The system was installed in 1968. It has a 30-year service life which expired in 1998.

Recommendation: The system should be replaced.

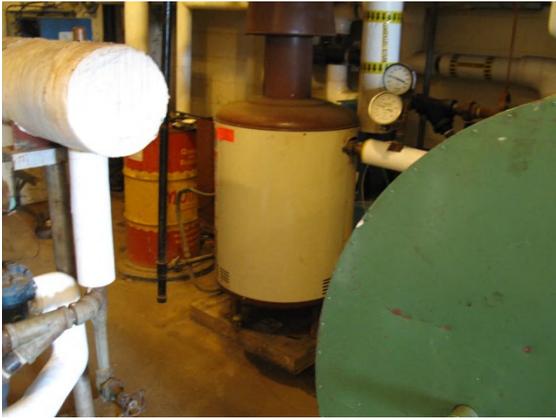
System: D2090 - Other Plumbing Systems-Nat Gas

Analysis: The system age is either beyond expected life or does not meet its intended performance under the Guidelines. The system may be in service and functioning but it is recommended to be replaced due to probable increased condition budget needs, the potential failure of its components, or in order to meet the performance Guidelines for this system. The system was installed in 1968. It has a 20-year service life which expired in 1988.

Recommendation: The system should be replaced.

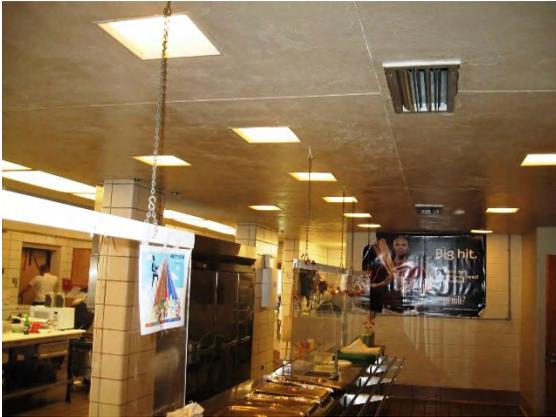
System: D5020 - Lighting and Branch Wiring

Analysis: The system age is either beyond expected life or does not meet its intended performance under the Guidelines. The system may be in service and functioning but it is recommended to be replaced due to probable increased condition budget needs, the potential failure of its components, or in order to meet the performance Guidelines for this system. The system was installed in 1968. It has a 30-year service life which expired in 1998.

Location: Grow Hall-Cafeteria
Distress: Beyond Expected Life
Category: Deferred Maintenance
Priority: 3 - Necessary- 2-5 Yrs
Correction: Renew System
Qty: 1-Ea.
Condition Budget: \$205,532

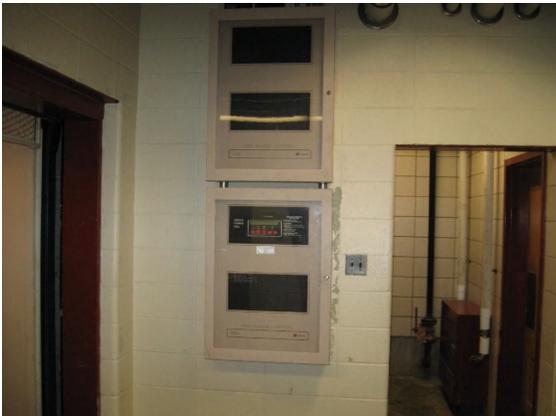
System: D5030 - Communications and Security

Analysis: The system age is either beyond expected life or does not meet its intended performance under the Guidelines. The system may be in service and functioning but it is recommended to be replaced due to probable increased condition budget needs, the potential failure of its components, or in order to meet the performance Guidelines for this system. The system was installed in 1988. It has a 20-year service life which expired in 2008.

Location: Grow Hall-Cafeteria
Distress: Beyond Expected Life
Category: Deferred Maintenance
Priority: 3 - Necessary- 2-5 Yrs
Correction: Renew System
Qty: 1-Ea.
Condition Budget: \$71,266

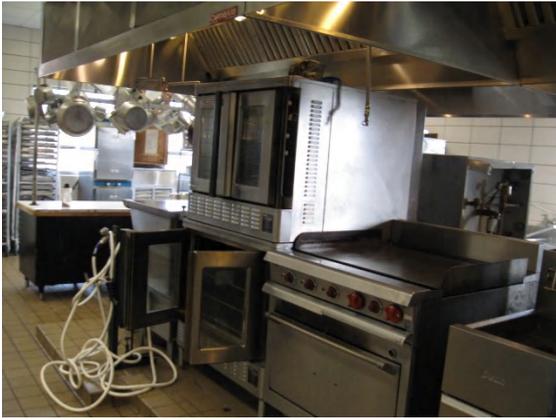
System: E1090 - Other Equipment

Analysis: The system age is either beyond expected life or does not meet its intended performance under the Guidelines. The system may be in service and functioning but it is recommended to be replaced due to probable increased condition budget needs, the potential failure of its components, or in order to meet the performance Guidelines for this system. The system was installed in 1985. It has a 20-year service life which expired in 2005.

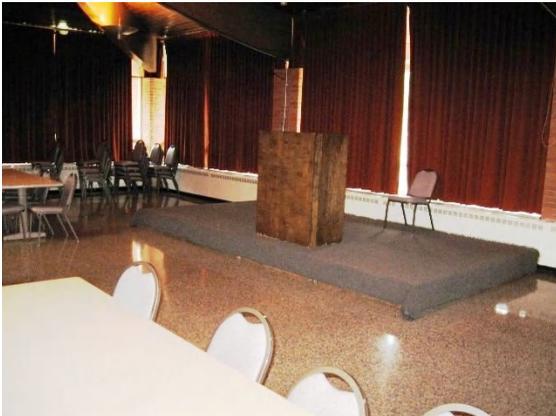
System: E2010 - Fixed Furnishings

Analysis: The system age is either beyond expected life or does not meet its intended performance under the Guidelines. The system may be in service and functioning but it is recommended to be replaced due to probable increased condition budget needs, the potential failure of its components, or in order to meet the performance Guidelines for this system. The system was installed in 1985. It has a 20-year service life which expired in 2005.

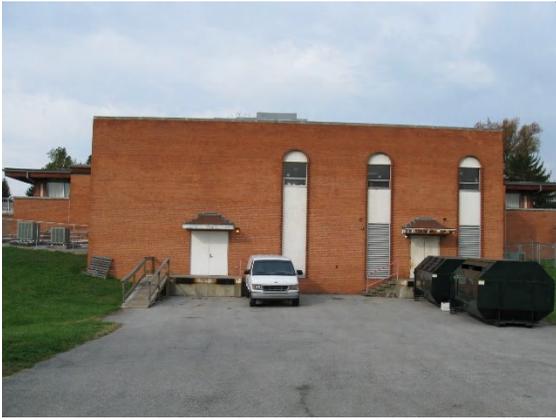
System: G2020 - Parking Lots

Analysis: The system age is either beyond expected life or does not meet its intended performance under the Guidelines. The system may be in service and functioning but it is recommended to be replaced due to probable increased condition budget needs, the potential failure of its components, or in order to meet the performance Guidelines for this system. The system was installed in 1968. It has a 30-year service life which expired in 1998.

Recommendation: The system should be replaced.

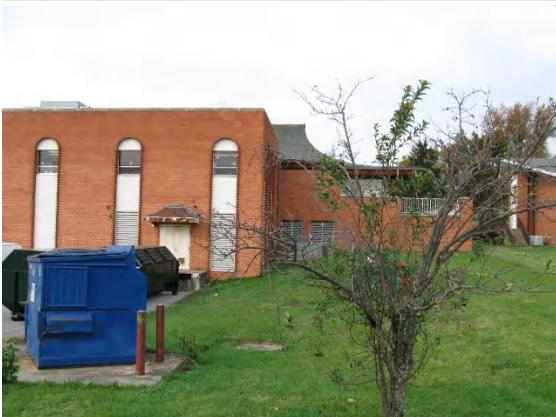
System: G2050 - Landscaping

Analysis: The system age is either beyond expected life or does not meet its intended performance under the Guidelines. The system may be in service and functioning but it is recommended to be replaced due to probable increased condition budget needs, the potential failure of its components, or in order to meet the performance Guidelines for this system. The system was installed in 1968. It has a 20-year service life which expired in 1988.

Recommendation: The system should be replaced.

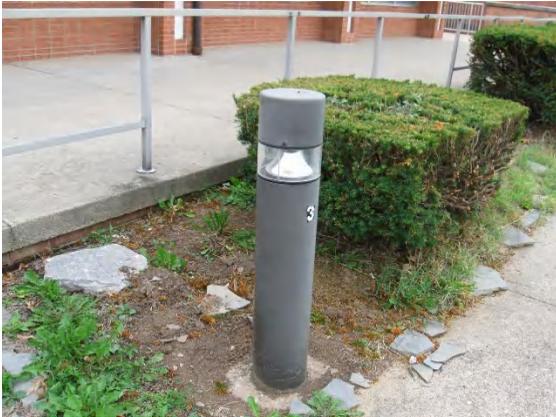
System: G4020 - Site Lighting

Analysis: The system age is either beyond expected life or does not meet its intended performance under the Guidelines. The system may be in service and functioning but it is recommended to be replaced due to probable increased condition budget needs, the potential failure of its components, or in order to meet the performance Guidelines for this system. The system was installed in 1980. It has a 30-year service life which expired in 2010.

Location: Grow Hall-Cafeteria
Distress: Beyond Expected Life
Category: Deferred Maintenance
Priority: 3 - Necessary- 2-5 Yrs
Notes: Pole and bollard type are beyond expected life.
Correction: Renew System
Qty: 1-Ea.
Condition Budget: \$23,296

Recommendation: The system should be replaced.

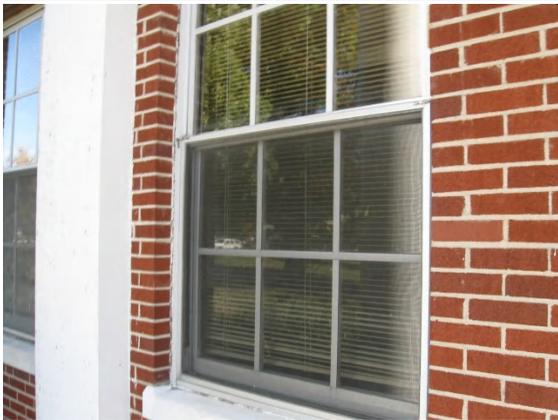
System: B2020 - Exterior Windows

Analysis: The system age is either beyond expected life or does not meet its intended performance under the Guidelines. The system may be in service and functioning but it is recommended to be replaced due to probable increased condition budget needs, the potential failure of its components, or in order to meet the performance Guidelines for this system. The system was installed in 1980. It has a 30-year service life which expired in 2010.

Recommendation: The system should be replaced.

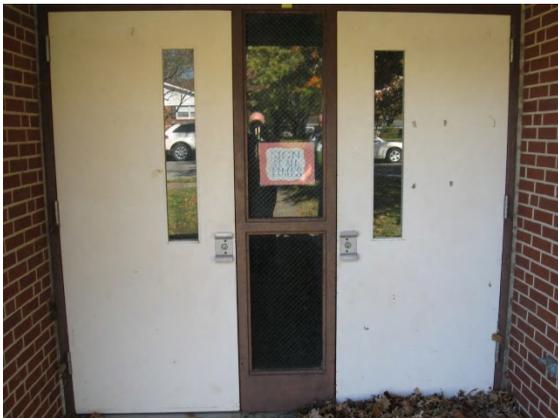
System: B2030 - Exterior Doors

Analysis: The system age is either beyond expected life or does not meet its intended performance under the Guidelines. The system may be in service and functioning but it is recommended to be replaced due to probable increased condition budget needs, the potential failure of its components, or in order to meet the performance Guidelines for this system. The system was installed in 1980. It has a 30-year service life which expired in 2010.

Recommendation: The system should be replaced.

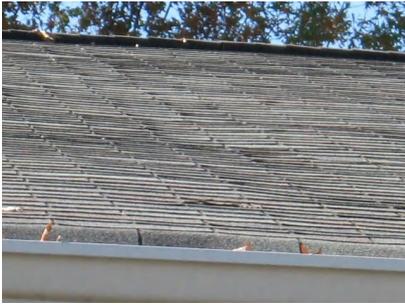
Analysis: The system age is either beyond expected life or does not meet its intended performance under the Guidelines. The system may be in service and functioning but it is recommended to be replaced due to probable increased condition budget needs, the potential failure of its components, or in order to meet the performance Guidelines for this system. The system was installed in 1990. It has a 20-year service life which expired in 2010.

Location: Nancy Lee Hall
Distress: Beyond Expected Life
Category: Deferred Maintenance
Priority: 3 - Necessary- 2-5 Yrs
Notes: Include replacement of gutters and downspouts with new roof covering.

Recommendation: The system should be replaced.

Correction: Renew System
Qty: 1-Ea.
Condition Budget: \$435,732

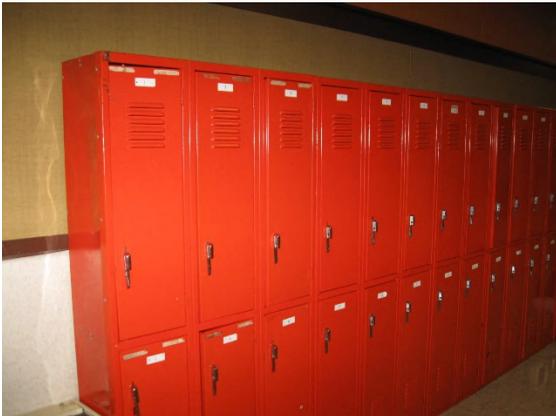
System: C1030 - Fittings

Analysis: The system age is either beyond expected life or does not meet its intended performance under the Guidelines. The system may be in service and functioning but it is recommended to be replaced due to probable increased condition budget needs, the potential failure of its components, or in order to meet the performance Guidelines for this system. The system was installed in 1980. It has a 20-year service life which expired in 2000.

Recommendation: The system should be replaced.

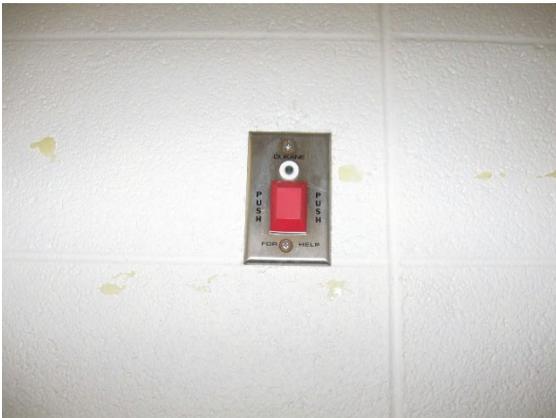
System: C3010 - Wall Finishes

Analysis: The system age is either beyond expected life or does not meet its intended performance under the Guidelines. The system may be in service and functioning but it is recommended to be replaced due to probable increased condition budget needs, the potential failure of its components, or in order to meet the performance Guidelines for this system. The system was installed in 1980. It has a 10-year service life which expired in 1990.

Recommendation: The system should be replaced.

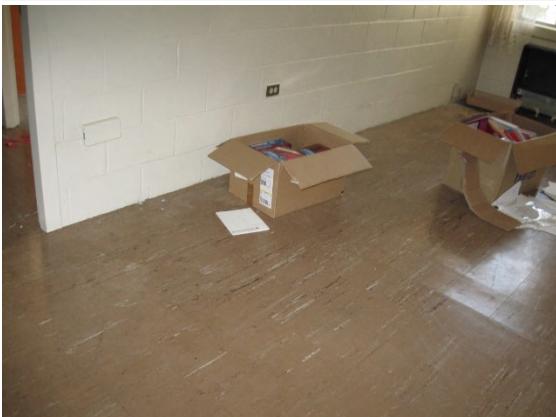
System: C3020 - Floor Finishes

Analysis: The system age is either beyond expected life or does not meet its intended performance under the Guidelines. The system may be in service and functioning but it is recommended to be replaced due to probable increased condition budget needs, the potential failure of its components, or in order to meet the performance Guidelines for this system. The system was installed in 1980. It has a 20-year service life which expired in 2000.

Recommendation: The system should be replaced.

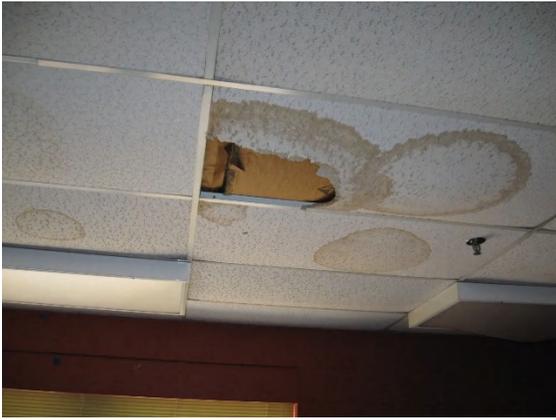
System: C3030 - Ceiling Finishes

Analysis: The system age is either beyond expected life or does not meet its intended performance under the Guidelines. The system may be in service and functioning but it is recommended to be replaced due to probable increased condition budget needs, the potential failure of its components, or in order to meet the performance Guidelines for this system. The system was installed in 1980. It has a 20-year service life which expired in 2000.

Recommendation: The system should be replaced.

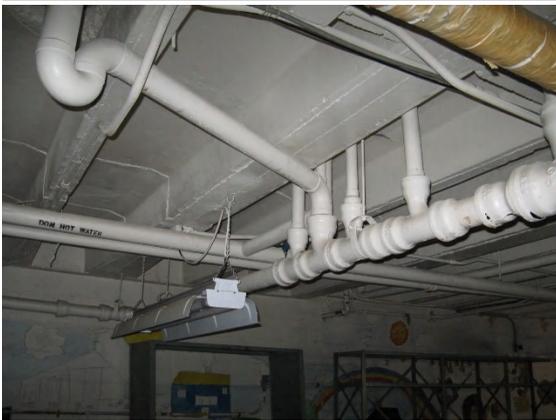
System: D2030 - Sanitary Waste

Analysis: The system age is either beyond expected life or does not meet its intended performance under the Guidelines. The system may be in service and functioning but it is recommended to be replaced due to probable increased condition budget needs, the potential failure of its components, or in order to meet the performance Guidelines for this system. The system was installed in 1980. It has a 30-year service life which expired in 2010.

Recommendation: The system should be replaced.

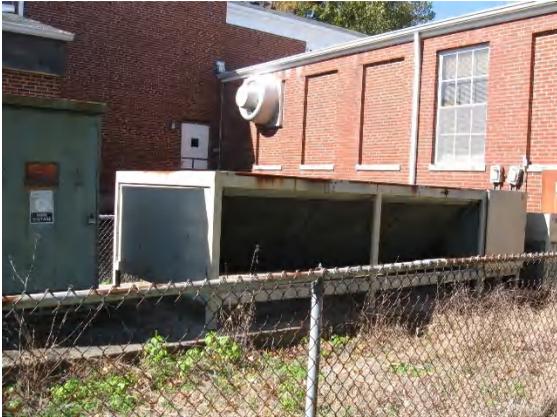
System: D3030 - Cooling Generating Systems

Analysis: The system age is either beyond expected life or does not meet its intended performance under the Guidelines. The system may be in service and functioning but it is recommended to be replaced due to probable increased condition budget needs, the potential failure of its components, or in order to meet the performance Guidelines for this system. The system was installed in 1980. It has a 30-year service life which expired in 2010.

Recommendation: The system should be replaced.

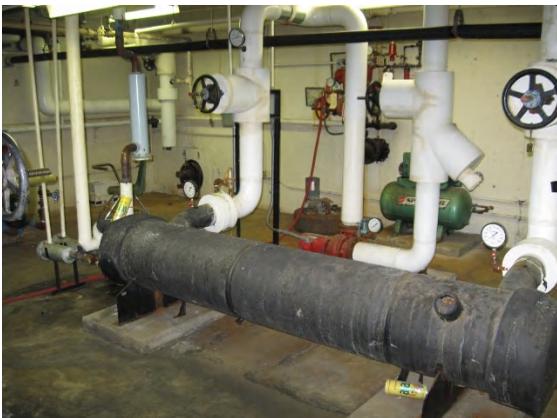
System: D3040 - Distribution Systems

Analysis: The system age is either beyond expected life or does not meet its intended performance under the Guidelines. The system may be in service and functioning but it is recommended to be replaced due to probable increased condition budget needs, the potential failure of its components, or in order to meet the performance Guidelines for this system. The system was installed in 1980. It has a 30-year service life which expired in 2010.

Recommendation: The system should be replaced.

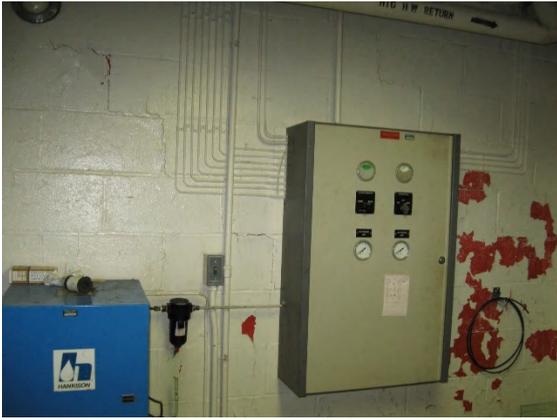
System: D3060 - Controls & Instrumentation

Analysis: The system age is either beyond expected life or does not meet its intended performance under the Guidelines. The system may be in service and functioning but it is recommended to be replaced due to probable increased condition budget needs, the potential failure of its components, or in order to meet the performance Guidelines for this system. The system was installed in 1980. It has a 20-year service life which expired in 2000.

Recommendation: The system should be replaced.

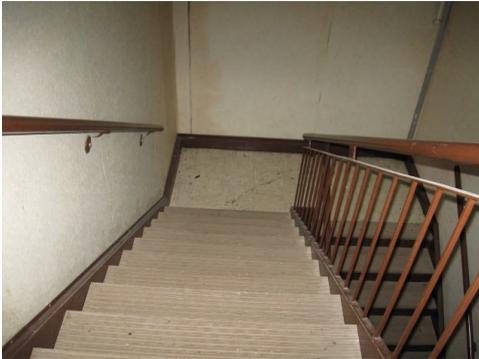
System: D4020 - Standpipes

Analysis: The system is missing.
Recommendation: The system should be installed.

Location: Nancy Lee Hall
Distress: Missing
Category: Compliance
Priority: 5 - Does Not Meet Current Code and/or Guidelines
Correction: Renew System
Qty: 1-Ea.
Condition Budget: \$7,722

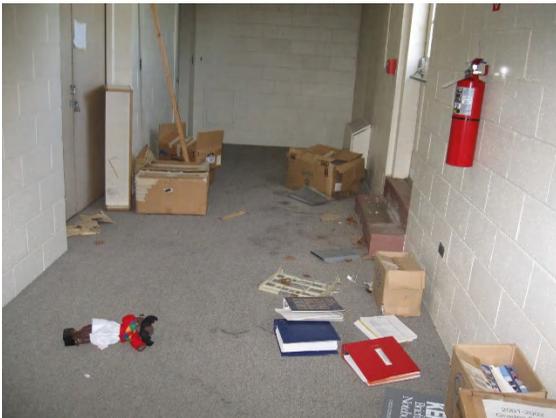
System: D4030 - Fire Protection Specialties

Analysis: The system age is either beyond expected life or does not meet its intended performance under the Guidelines. The system may be in service and functioning but it is recommended to be replaced due to probable increased condition budget needs, the potential failure of its components, or in order to meet the performance Guidelines for this system. The system was installed in 1980. It has a 15-year service life which expired in 1995.
Recommendation: The system should be replaced.

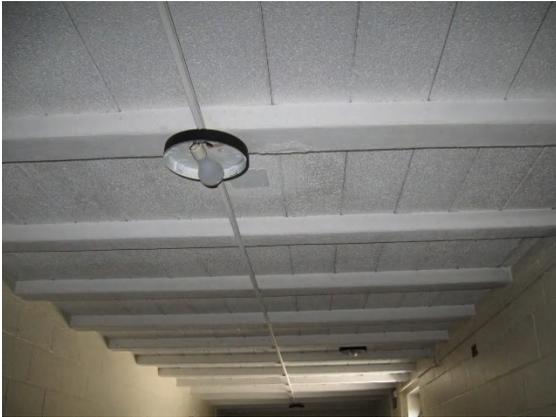
System: D5020 - Lighting and Branch Wiring

Analysis: The system age is either beyond expected life or does not meet its intended performance under the Guidelines. The system may be in service and functioning but it is recommended to be replaced due to probable increased condition budget needs, the potential failure of its components, or in order to meet the performance Guidelines for this system. The system was installed in 1980. It has a 30-year service life which expired in 2010.

Recommendation: The system should be replaced.

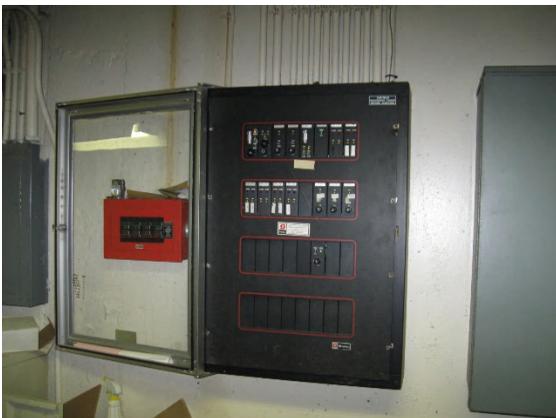
System: D5030 - Communications and Security

Analysis: The system age is either beyond expected life or does not meet its intended performance under the Guidelines. The system may be in service and functioning but it is recommended to be replaced due to probable increased condition budget needs, the potential failure of its components, or in order to meet the performance Guidelines for this system. The system was installed in 1980. It has a 20-year service life which expired in 2000.

Recommendation: The system should be replaced.

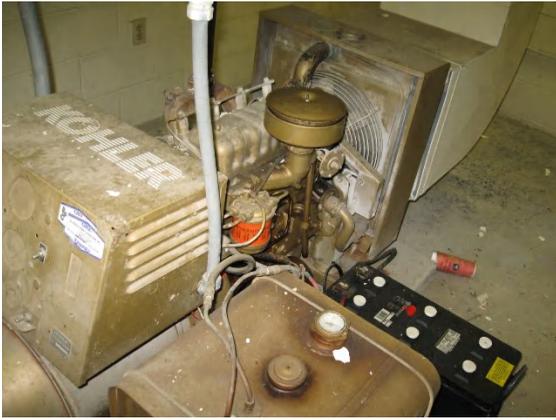
System: D5090 - Other Electrical Systems

Analysis: The system age is either beyond expected life or does not meet its intended performance under the Guidelines. The system may be in service and functioning but it is recommended to be replaced due to probable increased condition budget needs, the potential failure of its components, or in order to meet the performance Guidelines for this system. The system was installed in 1980. It has a 15-year service life which expired in 1995.

Recommendation: The system should be replaced.

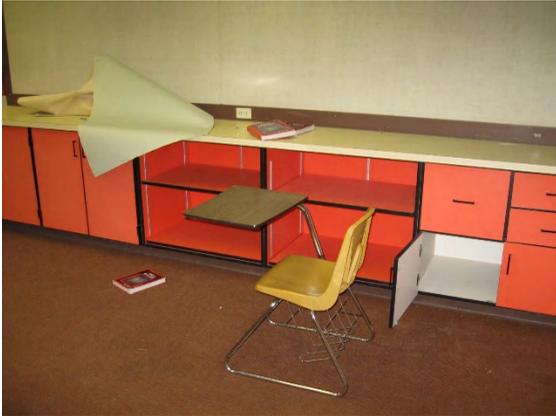
System: E2010 - Fixed Furnishings

Analysis: The system age is either beyond expected life or does not meet its intended performance under the Guidelines. The system may be in service and functioning but it is recommended to be replaced due to probable increased condition budget needs, the potential failure of its components, or in order to meet the performance Guidelines for this system. The system was installed in 1958. It has a 20-year service life which expired in 1978.

Recommendation: The system should be replaced.

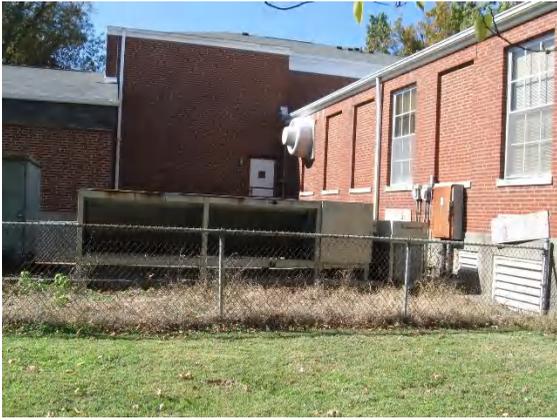
System: G2040 - Site Development

Analysis: The system age is either beyond expected life or does not meet its intended performance under the Guidelines. The system may be in service and functioning but it is recommended to be replaced due to probable increased condition budget needs, the potential failure of its components, or in order to meet the performance Guidelines for this system. The system was installed in 1980. It has a 30-year service life which expired in 2010.

Recommendation: The system should be replaced.
