School Assessment Report

District: Kentucky School of the Deaf

Report: Apr 11, 2012

Condition Assessment: Nov 18, 2011

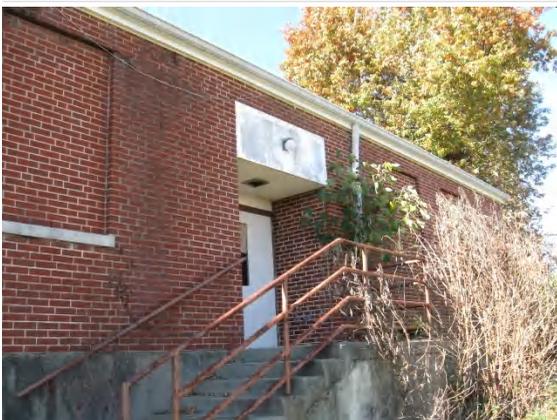
System: G2050 - Landscaping

Analysis: The system age is either beyond expected life or does not meet its intended performance under the Guidelines. The system may be in service and functioning but it is recommended to be replaced due to probable increased condition budget needs, the potential failure of its components, or in order to meet the performance Guidelines for this system. The system was installed in 1980. It has a 20-year service life which expired in 2000.

Recommendation: The system should be replaced.

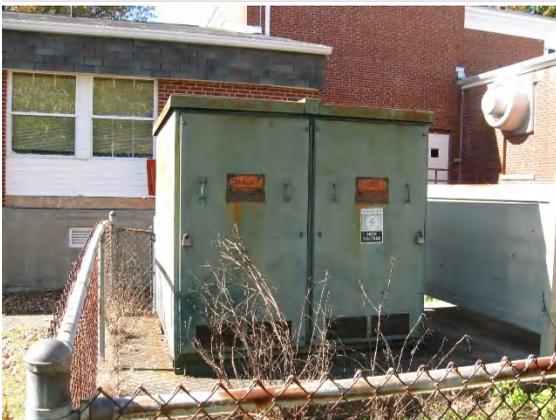
System: G4010 - Electrical Distribution

Analysis: The system age is either beyond expected life or does not meet its intended performance under the Guidelines. The system may be in service and functioning but it is recommended to be replaced due to probable increased condition budget needs, the potential failure of its components, or in order to meet the performance Guidelines for this system. The system was installed in 1980. It has a 30-year service life which expired in 2010.

Recommendation: The system should be replaced.

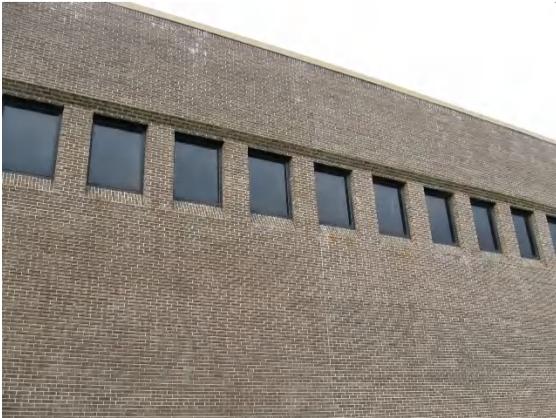
System: B2020 - Exterior Windows

Analysis: The system age is either beyond expected life or does not meet its intended performance under the Guidelines. The system may be in service and functioning but it is recommended to be replaced due to probable increased condition budget needs, the potential failure of its components, or in order to meet the performance Guidelines for this system. The system was installed in 1973. It has a 30-year service life which expired in 2003.

Recommendation: The system should be replaced.

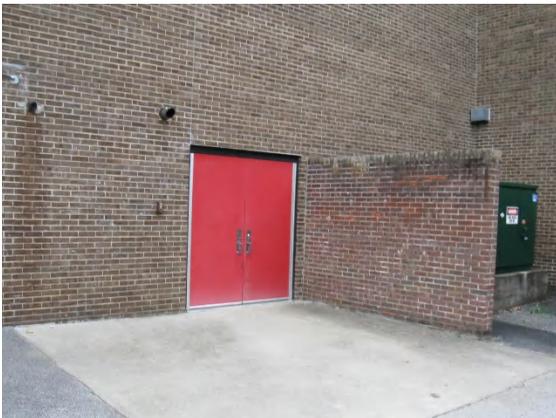
System: B2030 - Exterior Doors

Analysis: The system age is either beyond expected life or does not meet its intended performance under the Guidelines. The system may be in service and functioning but it is recommended to be replaced due to probable increased condition budget needs, the potential failure of its components, or in order to meet the performance Guidelines for this system. The system was installed in 1973. It has a 30-year service life which expired in 2003.

Recommendation: The system should be replaced.

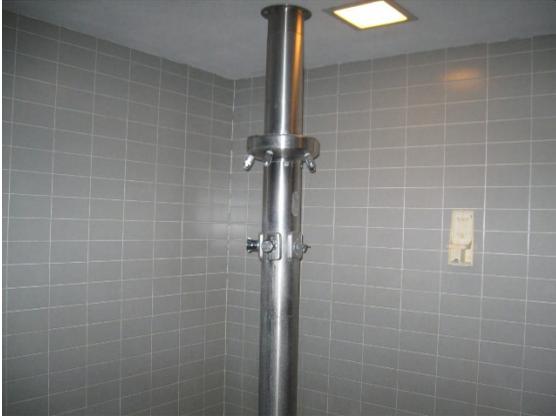
System: D2010 - Plumbing Fixtures

Analysis: The system age is either beyond expected life or does not meet its intended performance under the Guidelines. The system may be in service and functioning but it is recommended to be replaced due to probable increased condition budget needs, the potential failure of its components, or in order to meet the performance Guidelines for this system. The system was installed in 1973. It has a 30-year service life which expired in 2003.

Location: Thomas Gym
Distress: Beyond Expected Life
Category: Deferred Maintenance
Priority: 3 - Necessary- 2-5 Yrs
Correction: Renew System
Qty: 1-Ea.
Condition Budget: \$271,661

Recommendation: The system should be replaced.

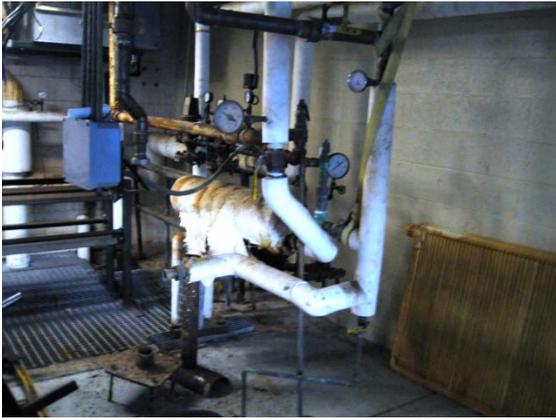
System: D3040 - Distribution Systems

Analysis: The system age is either beyond expected life or does not meet its intended performance under the Guidelines. The system may be in service and functioning but it is recommended to be replaced due to probable increased condition budget needs, the potential failure of its components, or in order to meet the performance Guidelines for this system. The system was installed in 1973. It has a 30-year service life which expired in 2003.

Notes: Building does not have cooling capabilities, heat only. Recommend adding package units with cooling and fresh air ventilation to better control IAQ in the gym. An Engineering Study of the HVAC requirements is recommended before any repairs or renovations are implemented.

Recommendation: The system should be replaced.

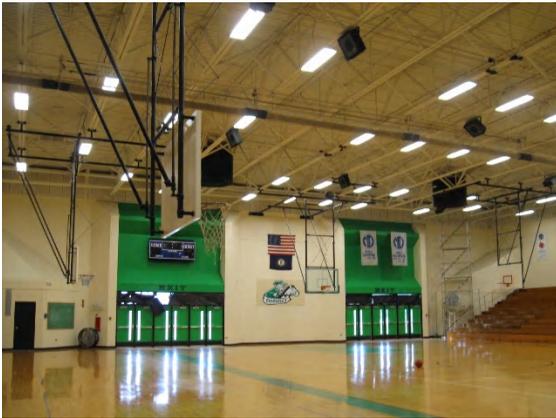
System: D3070 - Systems Testing & Balance

Analysis: The system age is either beyond expected life or does not meet its intended performance under the Guidelines. The system may be in service and functioning but it is recommended to be replaced due to probable increased condition budget needs, the potential failure of its components, or in order to meet the performance Guidelines for this system. The system was installed at an unknown date. It has a 30-year service life.

Notes: Gym does not have cooling capabilities, heat only. Recommend adding package units with cooling and fresh air ventilation to better control IAQ in the gym. An Engineering Study of the HVAC requirements is recommended before any repairs or renovations are implemented.

Recommendation: The system should be replaced.

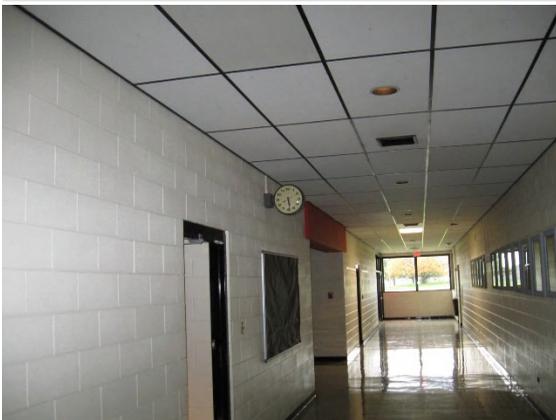
System: D5020 - Lighting and Branch Wiring

Analysis: The system is in use and functioning with an estimated remaining service life as indicated in the report section "Condition/Replacement Budget Detail". The system was installed in 2009. It has a 30-year service life. However, in the assessment, it was found to be currently deficient.

Recommendation: The system should be replaced.

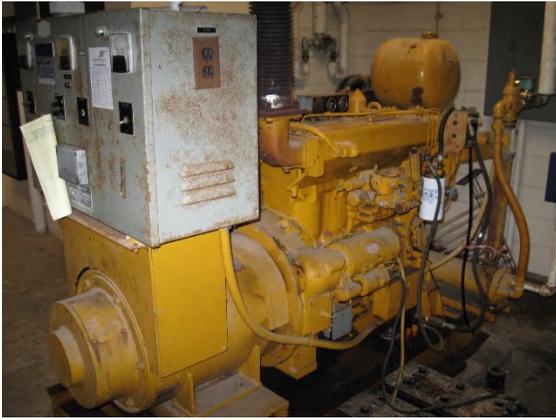
System: D5090 - Other Electrical Systems

Analysis: The system age is either beyond expected life or does not meet its intended performance under the Guidelines. The system may be in service and functioning but it is recommended to be replaced due to probable increased condition budget needs, the potential failure of its components, or in order to meet the performance Guidelines for this system. The system was installed in 1973. It has a 15-year service life which expired in 1988.

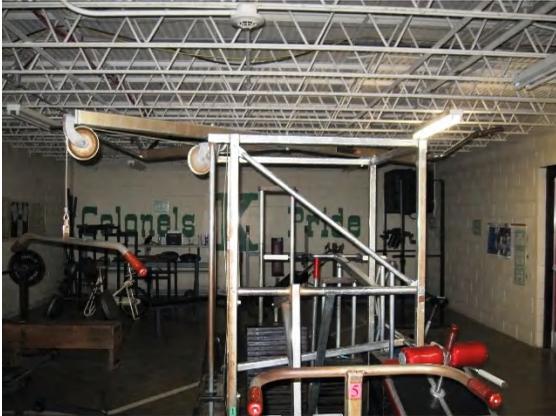
System: E1090 - Other Equipment

Analysis: The system age is either beyond expected life or does not meet its intended performance under the Guidelines. The system may be in service and functioning but it is recommended to be replaced due to probable increased condition budget needs, the potential failure of its components, or in order to meet the performance Guidelines for this system. The system was installed in 1983. It has a 20-year service life which expired in 2003.

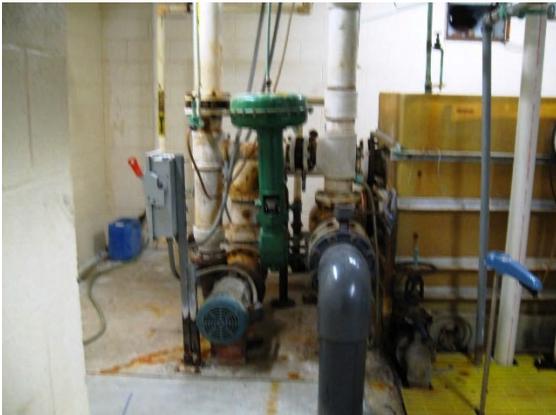
System: F1040 - Special Facilities-Swimming Pool

Analysis: The system is in use and functioning with an estimated remaining service life as indicated in the report section "Condition/Replacement Budget Detail". The system was installed in 2000. It has a 20-year service life. However, in the assessment, it was found to be currently deficient.

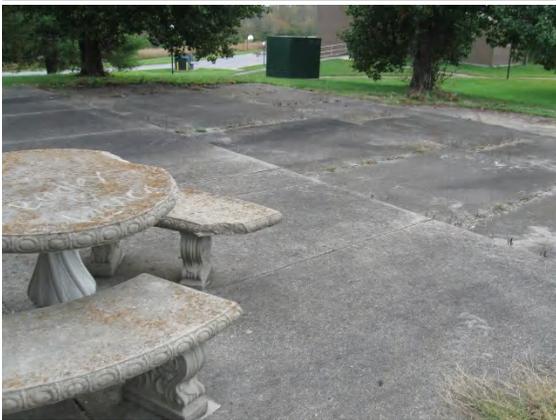
System: G2040 - Site Development

Analysis: The system age is either beyond expected life or does not meet its intended performance under the Guidelines. The system may be in service and functioning but it is recommended to be replaced due to probable increased condition budget needs, the potential failure of its components, or in order to meet the performance Guidelines for this system. The system was installed in 1973. It has a 30-year service life which expired in 2003.

Location: Thomas Gym
Distress: Beyond Expected Life
Category: Deferred Maintenance
Priority: 4 - Recommended-3-10 Yrs
Notes: G 2040 Site Development-Includes: fences & gates
• retaining walls
• terrace & perimeter walls
• signs
• site furnishings
• fountains, pools, & watercourses
• playing fields
• flagpoles
• miscellaneous structures

Correction: Renew System
Qty: 1-Ea.
Condition Budget: \$34,615

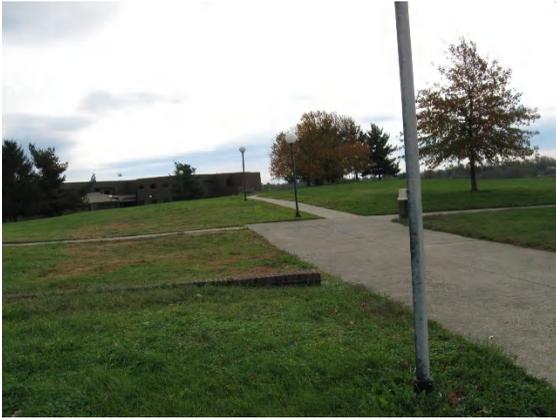
System: G2050 - Landscaping

Analysis: The system age is either beyond expected life or does not meet its intended performance under the Guidelines. The system may be in service and functioning but it is recommended to be replaced due to probable increased condition budget needs, the potential failure of its components, or in order to meet the performance Guidelines for this system. The system was installed in 1973. It has a 20-year service life which expired in 1993.

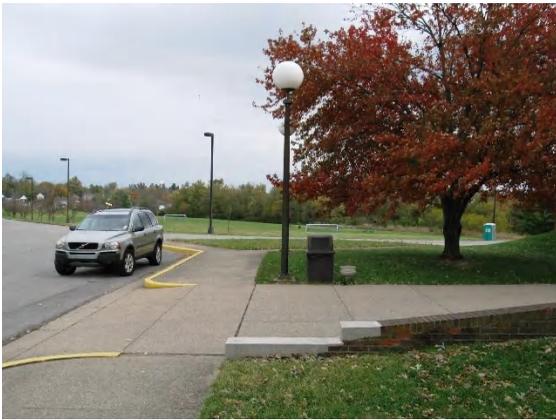
System: G4020 - Site Lighting

Analysis: The system age is either beyond expected life or does not meet its intended performance under the Guidelines. The system may be in service and functioning but it is recommended to be replaced due to probable increased condition budget needs, the potential failure of its components, or in order to meet the performance Guidelines for this system. The system was installed in 1973. It has a 30-year service life which expired in 2003.
